Ruggedized and Improved MEMS-based Sensors for Rolling Stock

ABSTRACT

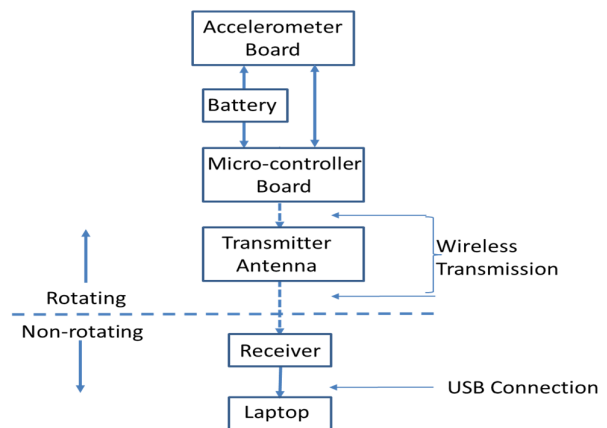
Figure 1. Simple MEMS block diagram [2]

For more complex systems, especially those with poor signal transmission paths, a shaft-mounted, wireless solution based on a micro-electro-mechanical system (MEMS) is needed (see Figure 1) [1] [2] [3] [4].

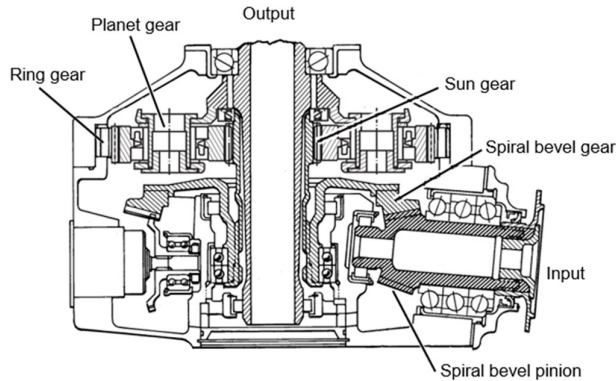
Figure 2. Illustration of an OH-58C transmission

A specific application was the spiral-bevel pinion of an OH-58C transmission (see Figure 2). For that application, MEMS Sensing Package was designed and developed to contain Figure 4a microcontroller board, an accelerometer board, and a battery pack mounted in a cylindrical canister (Figure 3 and Figure 4).

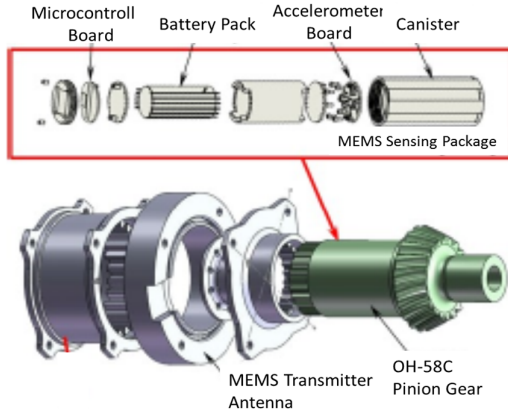
Figure 3. RotoSense mounted on an OH-58C pinion gear

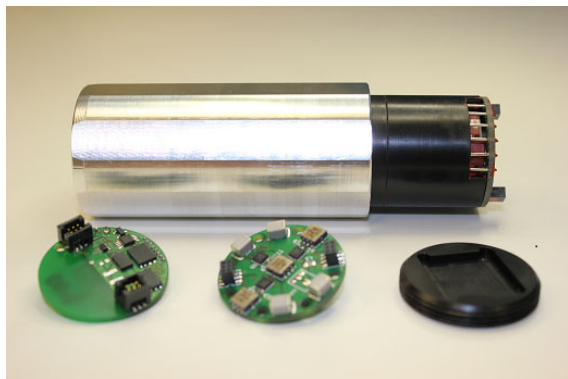
Figure 4. Canister, boards, and end cap

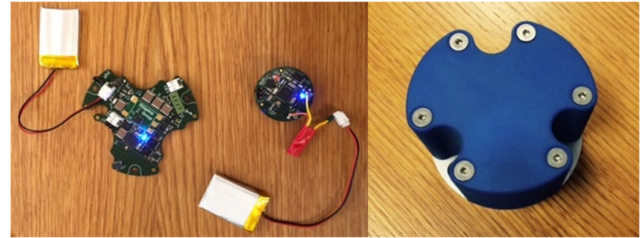
Figure 5. Boards with batteries and housing assembly

Figure 5 shows the physical adaptation of the MEMS-based sensor for mounting on wheel hubs of the shafts of the trucks of train locomotives and cars. This version of the sensor was designed and developed to prove feasibility for using such sensors to locate and identify anomalies related to railroad tracks.

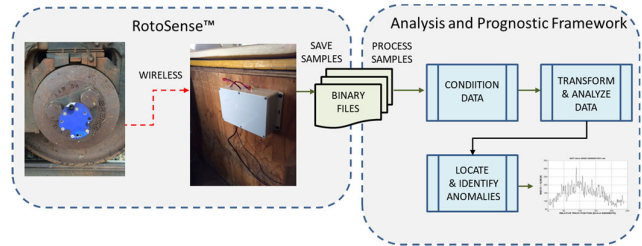
Figure 6. Block diagram of a rolling-stock sensor system

Referring to Figure 6, the adapted system for rolling stock applications comprises a MEMS sensor and a gateway to collect data and write data to disk storage as files. The MEMS sensors were mounted on wheels of a train to produce shock data during test runs of a train over a High Tonnage Loop (HTL) test track (TT) to process the data, identify high-force events (HFEs), and locate the position on the HTL TT where HFEs occurred. The purpose was to demonstrate/validate an ability to support focused inspection of tracks to identify and locate anomalies requiring monitoring and service [2].

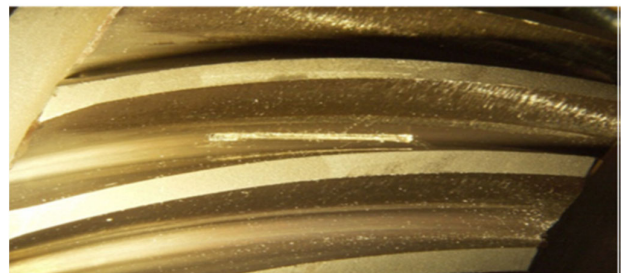
Figure 7. Final notching of the gear tooth

Triaxle-shaft-mounted MEMS sensors, RotoSense, were installed on pre-notched OH-58C spiral-bevel pinion gears and endurance tests at NASA's Glenn Research Center were performed and run to tooth fracture failure: the notch was extended at run time = 51.9 hours and widened at run time = 106 hours: see Figure 7.

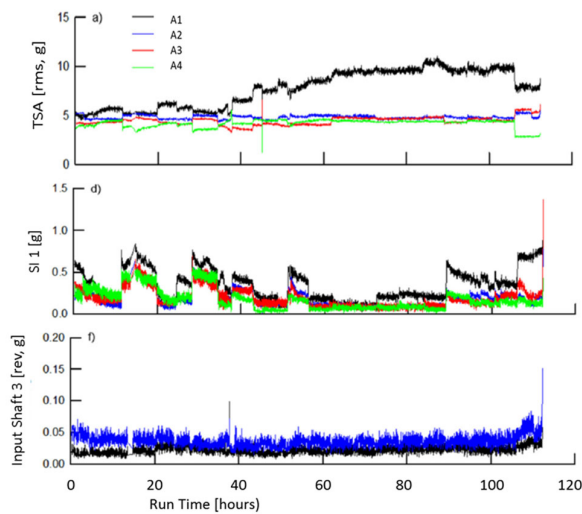
Figure 9. Example data: detection, condition indicators

For both the MEMS sensors and stationary sensors, the fault detection time was not much sooner than the actual tooth fracture time. The MEMS sensor spectrum data showed large first order shaft frequency sidebands due to the measurement rotating frame of reference. The method of constructing a pseudo tach signal from periodic characteristics of the vibration data was successful in deriving time-synchronous-average (TSA) signals (Figure 9) without an actual tach; the method proved to be an effective way to improve fault detection for the MEMS [1].

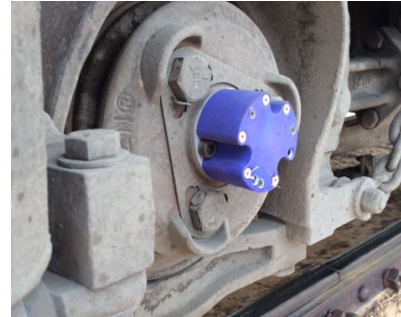
Figure 10: RotoSense mounted on a wheel hub

The configuration for train applications includes RotoSense, a MEMS sensor, supporting firmware and software to support collecting, wireless transmitting of data to a gateway, and saving data in binary files. The assemblies are mounted to the wheel hubs to rotate with the axle so any anomalies in the wheels or track can be detected (see Figure 10).

The MEMS is configured as a three-axis accelerometer with 57mV/g sensitivity with a 161 Hz sampling rate: sensor was mounted concentrically on each end of a freight car axle and also on a locomotive axle of a train, as shown back in Figure 10.

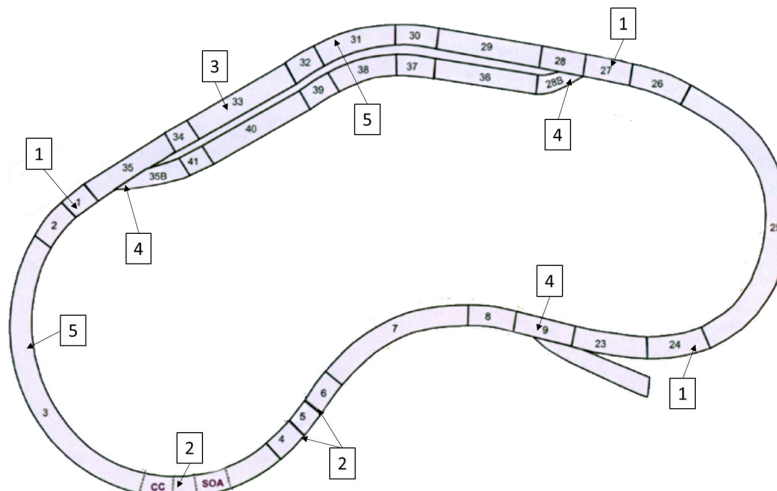
Figure 11. Layout of the Heavy Tonnage Loop Test Track.

The HTL track length is 2.7 miles divided into test sections that generally correspond to tangents, spirals, curves, and turnouts that are populated with features and test sections, as seen in Figure 11.

Table 1. Physical Features of the HTL TT – refer back to Figure 11

1. Lubricator	2. Steel Bridge	3. Crib Ties and Fasteners
4. 405, 407 or 408 turnout and frog or switch	5. Thermite or Overlay Welds	6. Concrete Bridge

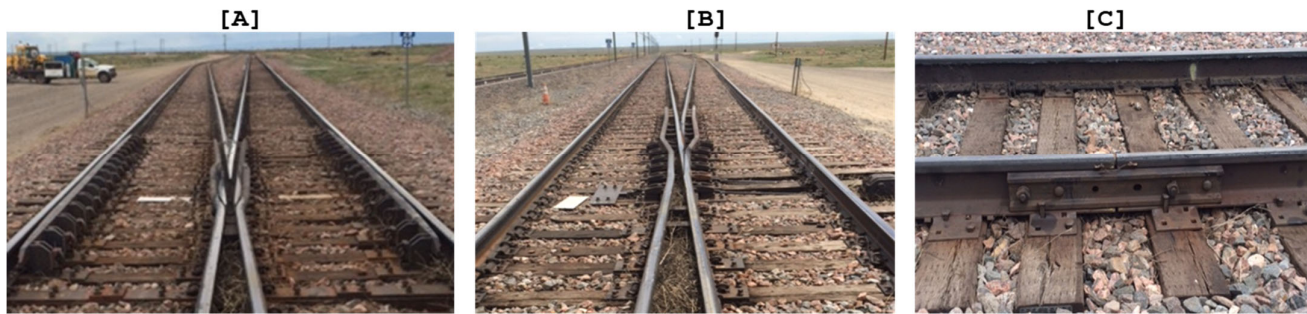
Figure 12. Turnout and frog, switch left [A] and switch Right [B]; steel bridge [C].

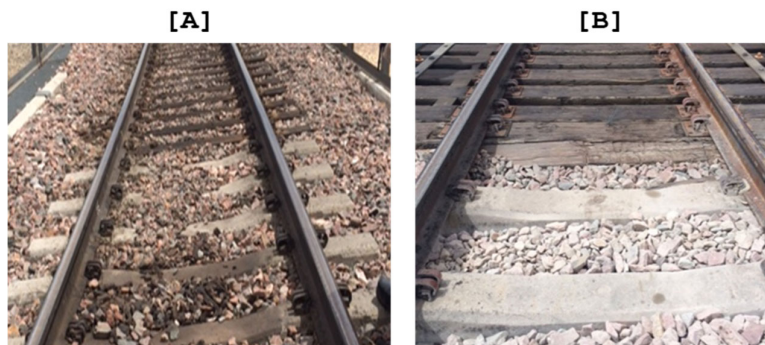
Figure 13: Concrete bridges [A]; crib ties, top of [B]; concrete bridges, bottom of [B].

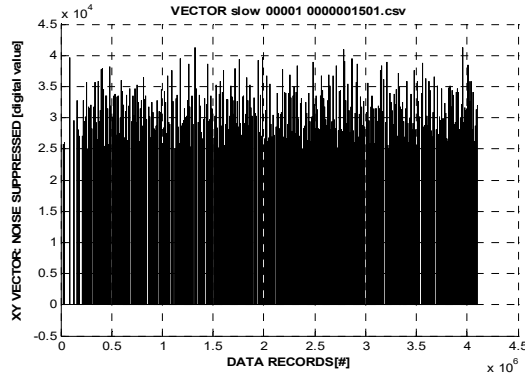
Figure 14. Raw data, xy-plane

(see Figure 14) was analyzed by binning the data in terms of magnitude (xy-plane, the z-plane, and both planes) and relative laps (see Figure 15), examining the peaks, and comparing those peaks to features of the test track:

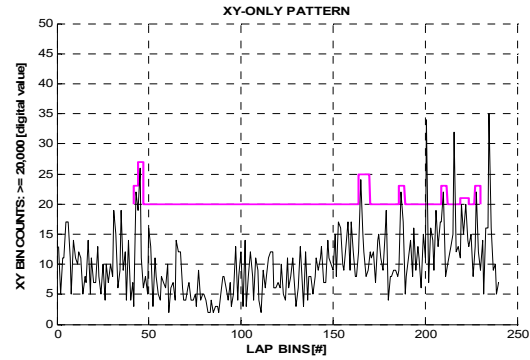
Figure 15. Binned data, xy-plane, by lap-bin number

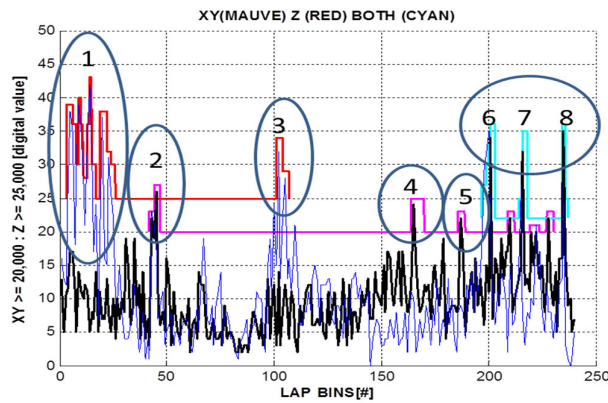
Figure 16. Data and identified features -see Table 3 for (1) through (8) association to feature and location

Track Sections	Feature Sections	TT ID	Track Feature	Detection Evaluation	
				XY-vector	Z-vector
1 – 3		S1	Lubricator	ND	ND
4 – 5		S2			
6 – 62	5-26	S3	Repair/overlay welds		Yes (1)
	30-40	S3	Concrete bridge	maybe	maybe
	42-46	S3	Concrete bridge	maybe	Yes (2)
63 – 66		S4	Steel bridges	ND	ND
67 – 69		S5	Bridge deflection	ND	ND
70 – 73		S6	Steel bridges	ND	ND
74 – 92		S7	Rail performance	ND	ND
93 – 97		S8	Fiber optic cable	ND	ND
98 – 108		S9	405 turnout/frog		Yes (3)
109 – 117		S23	405 turnout/frog		Yes (3)
118 – 125		S24	Lubricator	ND	ND
126 – 163		S25	TPO, Tie and fastener, performance	Yes (4)	No
164 – 170		S26			
171 – 175		S27	Lubricator	ND	ND
176 – 180		S28	Turn out, steering switch, foundation	Yes (5)	
181 – 193		S29	LTM Tests	ND	ND
194 – 198		S30			
199 – 208		S31	FRA: Rail-seat deterioration, Thermite welds	Yes (6)	Yes (6)
209 – 212		S32			
213 – 225		S33	Crib ties	Yes (7)	Yes (7)
226 – 229		S34			
230 – 240		S35	407 turnout/frog	Yes (8)	Yes (8)

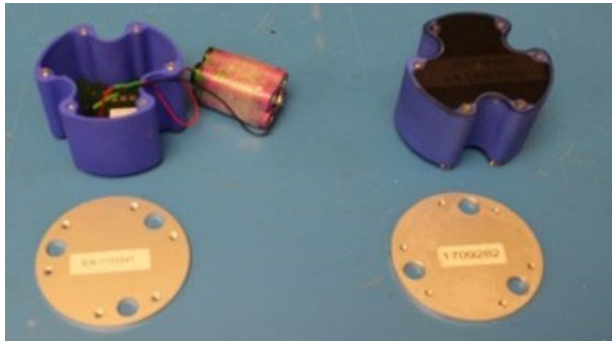
Figure 17. Original (left) and improved (right) sensors

Final testing of the improved MEMS-based sensor, see Figure 17, was performed at the National Technical Systems (NTS) test facilities in Tempe, Arizona and at Ridgetop Group laboratories in Tucson, Arizona.

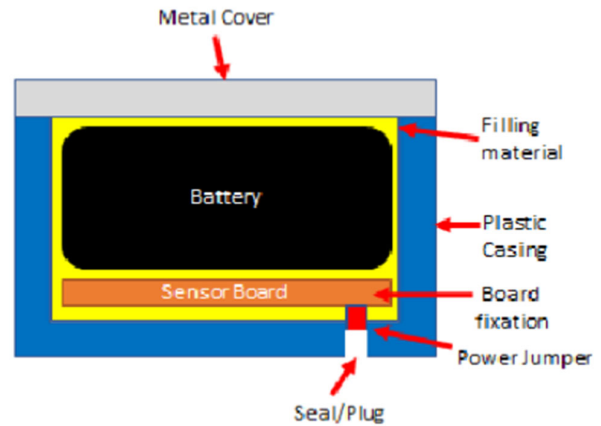
Figure 18. Component placement diagram

Experiments were performed using variations of component placement: the highest quality signals were obtained using the component placement shown in Figure 18.

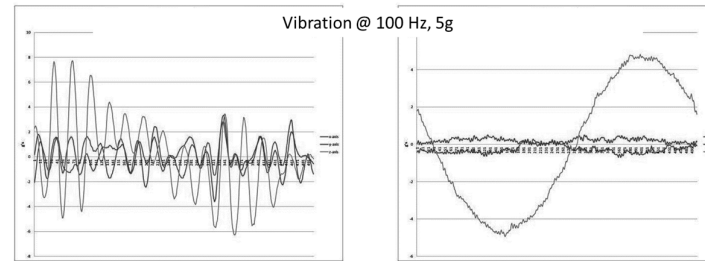
Figure 19. Vibration @ 100 Hz, 5g – before (left) and after (right) repositioning and potting

After potting and repositioning of components, the signal quality is significantly improved as seen in Figure 19 through Figure 22.

The output signals from the MEMS-based sensor after repositioning and potting of the boards and battery pack no longer exhibit extreme harmonic distortion and noise; the amplitudes more accurately reflect the magnitude of the vibration force; and the bandwidth has been improved from 4-6 Kb/s to 20-22 Kb/s.

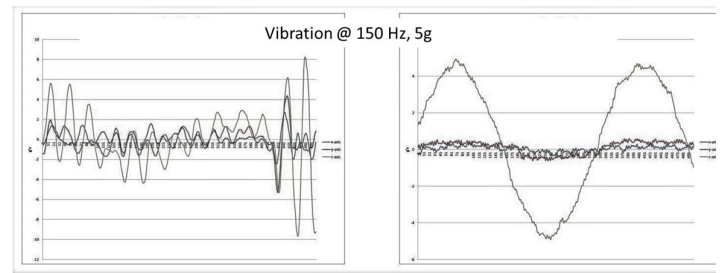
Figure 20. Vibration @ 150 Hz, 5g – before (left) and after (right) repositioning and potting

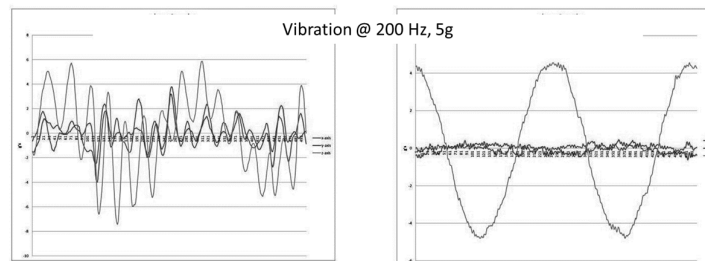
Figure 21. Vibration @ 200 Hz, 5g – before (left) and after (right) repositioning and potting

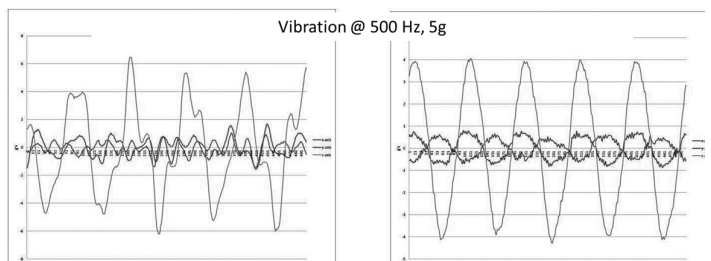
Figure 22. Vibration @ 500 Hz, 5g – before (left) and after (right) repositioning and potting
