# Improving a MEMS-based Sensor for Helicopter Gearbox and Rolling Stock Applications

Ridgetop Group, Inc.

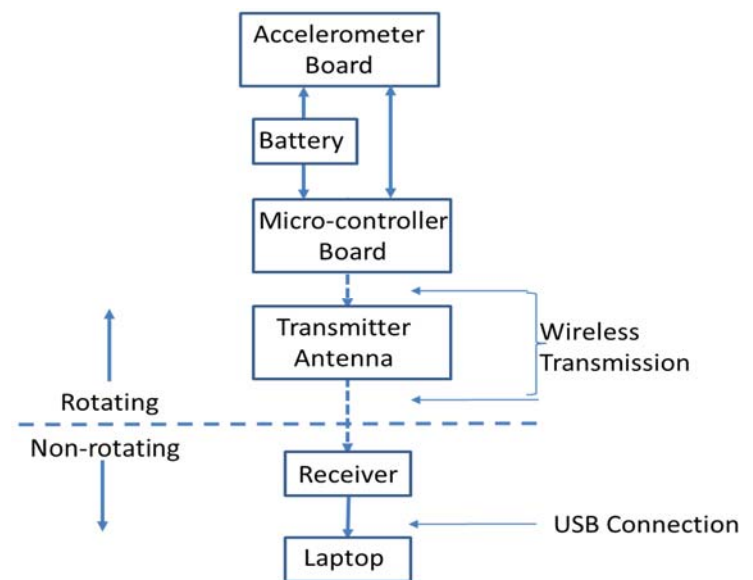
Figure 1. Simple MEMS block diagram [2]

maintenance (CBM) systems. Fault detection equipment on drive systems, such as those use for land, sea, and air vehicles, typically use accelerometers mounted on transmission housing to capture, measure, and process vibration signals. The usefulness and flexibility of such detection equipment for applications involving rotating shafts, including pinion and planetary gears, have been limited by cabling, slip-ring approaches, and multiple sensors to obtain monitoring information. For more complex systems, especially those with poor signal transmission paths, a shaft-mounted, wireless solution based on a micro-electro-mechanical system (MEMS) is needed (see Figure 1) [1],[2].

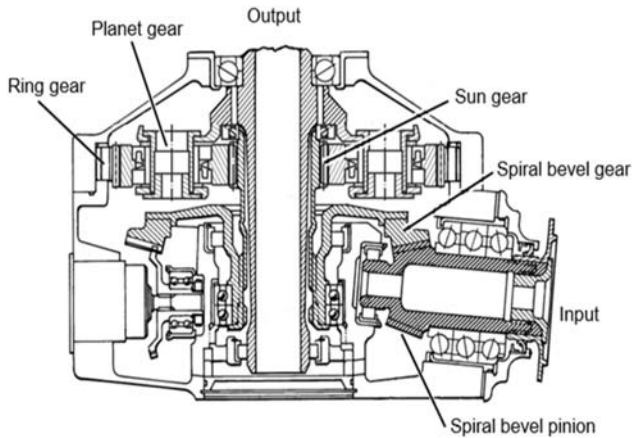
**Figure 2. Illustration of an OH-58C transmission**

**Helicopter Transmission: Pinion Gear**—A specific application was the pinion gear of an OH-58C transmission (see Figure 2 and Figure 3). A NASA Glenn Research Center, Small Business Innovation Research (SBIR) award led to an experiment in which a tooth on the spiral bevel gear was pre-notched and then the transmission was run to tooth failure.

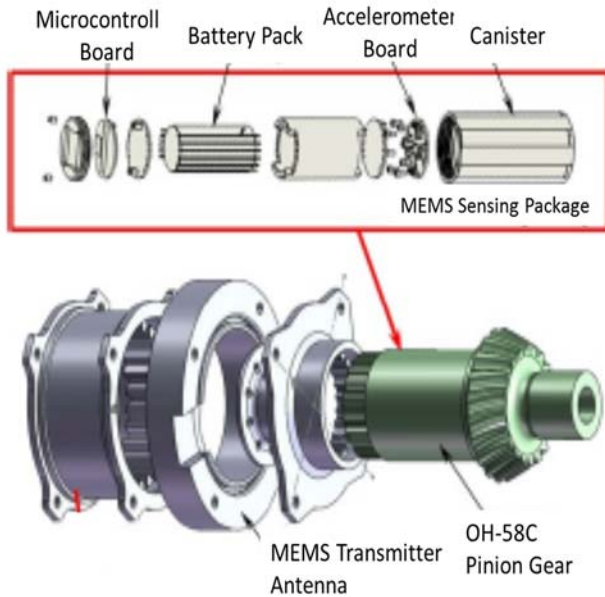
**Figure 3. Diagram of MEMS sensor mounted on an OH-58C pinion gear**

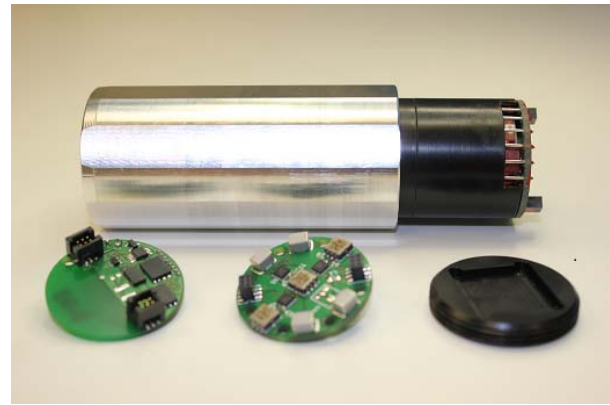
Figure 4 shows a partially disassembled MEMS sensor: the sensor comprises a microcontroller board, an accelerometer board, and a battery pack mounted in cylindrical canister.

**Figure 4. Canister, boards, and end cap**

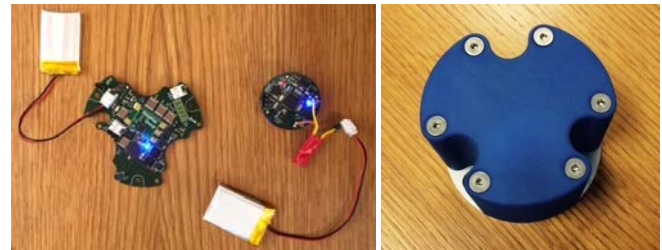
**Figure 5. Boards with batteries and housing assembly**

*Wheel Hubs of Rolling Stock*—A second example is the physical adaptation of the sensor for mounting on wheel hubs of the shafts of the trucks of train locomotives and cars (see Figure 5). This version of the MEMS sensor was designed and developed to prove feasibility for using such sensors to locate and identify anomalies related to railroad tracks.

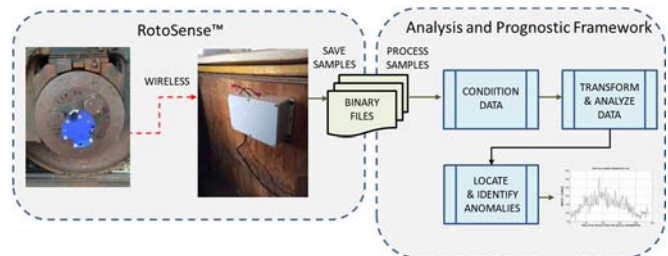
Referring to Figure 6, the adapted system comprises a MEMS sensor and a gateway to collect data, and write data to disk storage as files. The MEMS sensors were mounted on wheels of a train to produce shock data during test runs of a train over a High Tonnage Loop (HTL) test track (TT) to process the data, identify high-force events (HFEs), and locate the position on the HTL TT where HFEs occurred. The purpose was to demonstrate/validate an ability to support focused inspection of tracks to identify and locate anomalies requiring monitoring and service [2].

**Figure 6. Block diagram of a rolling-stock sensor system**

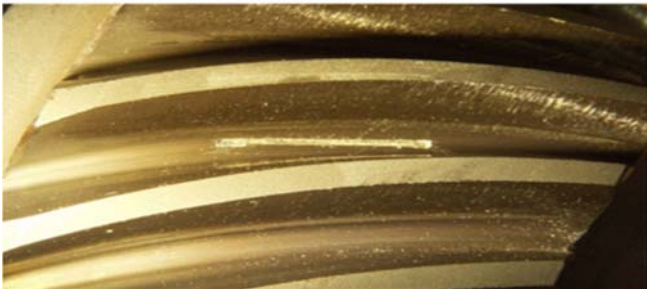
Triaxle-shaft-mounted MEMS sensors, RotoSense™, were installed on pre-notched OH-58C spiral-bevel pinion gears and endurance tests at NASA's Glenn Research Center were performed and run to tooth fracture failure: the notch was extended at run time = 51.9 hours and widened at run time = 106 hours: see Figure 7.

**Figure 7. Final notching of the gear tooth**

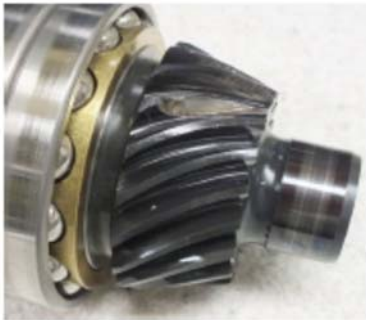
The sensors performed well, lasted the entire test, and all MEMS accelerometers gave an indication of failure at the end of the test. The MEMS systems performed as well, if not better, than the existing stationary accelerometers mounted on the gear box housing with regards to gear tooth fault detection (Figure 8).

**Figure 8. Failed gear – fractured tooth.**

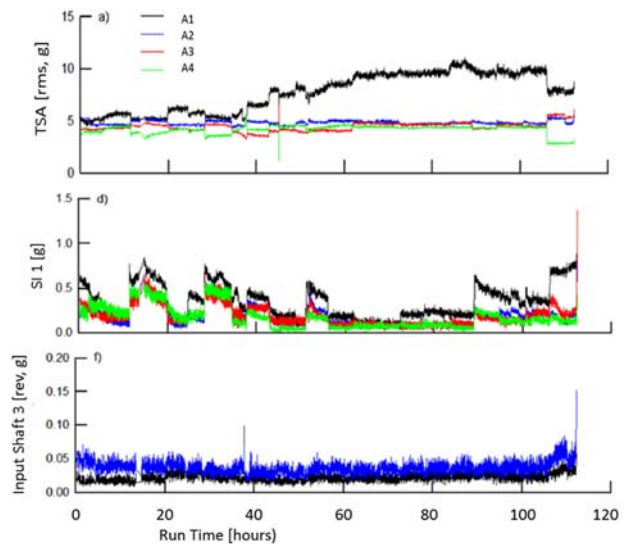
For both the MEMS sensors and stationary sensors, the fault detection time was not much sooner than the actual tooth fracture time. The MEMS sensor spectrum data showed large first order shaft frequency sidebands due to the measurement rotating frame of reference. The method of constructing a pseudo tach signal from periodic characteristics of the vibration data was successful in deriving time-synchronous-average (TSA) signals (Figure 9) without an actual tach, and proved an effective way to improve fault detection for the MEMS [1].

**Figure 9. Example data: detection, condition indicators**

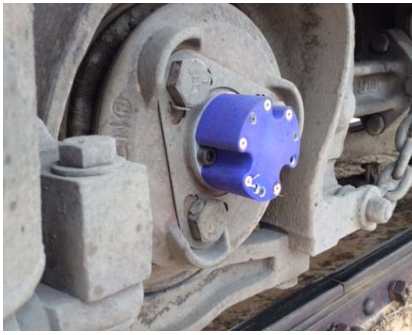
**MEMS Configuration and Test Setup**—The configuration for train applications includes a MEMS sensor, supporting firmware and software to support collecting, wireless transmitting of data to a gateway, and saving data in binary files. The assemblies are mounted to the wheel hubs to rotate with the axle so any anomalies in the wheels or track can be detected. The MEMS is configured as a three-axis accelerometer with 57mV/g sensitivity with a 161 Hz sampling rate: sensor was mounted concentrically on each

end of a freight car axle and also on a locomotive axle of a train (see Figure 10).

**Figure 10: MEMS sensor mounted on a wheel hub**

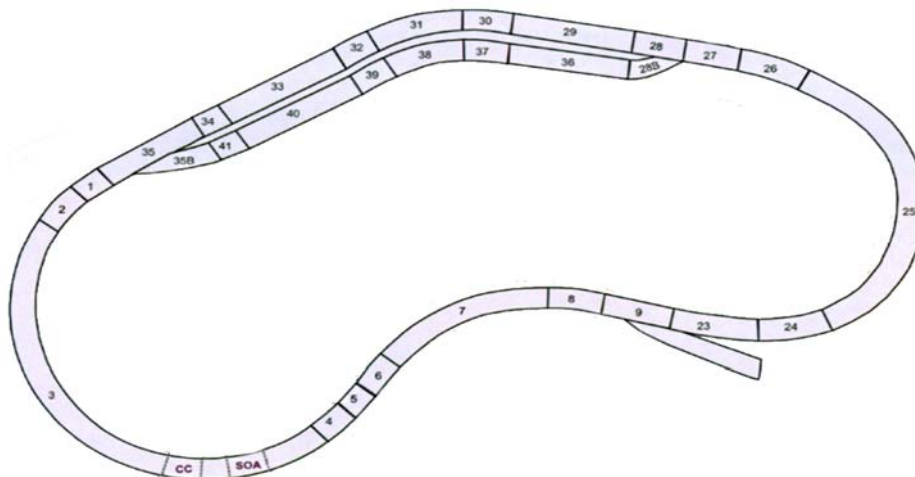
**Test Track**—The HTL track length is 2.7 miles divided into test sections that generally correspond to tangents, spirals, curves, and turnouts that are populated with features and test sections, as seen in Figure 11.

**Figure 11. Layout of the Heavy Tonnage Loop Test Track.**

**Table 1. Features of the HTL TT – refer to Figure 11**

1. Lubricator	2. Steel Bridge	3. Crib Ties
4. 405 turnout and frog	5. Thermite Welds	6. Rail Temperature
7. Rail Performance Test	8. Concrete Bridge	9. LTM Tests
10. Machine Vision	11. Fiber Optic cable

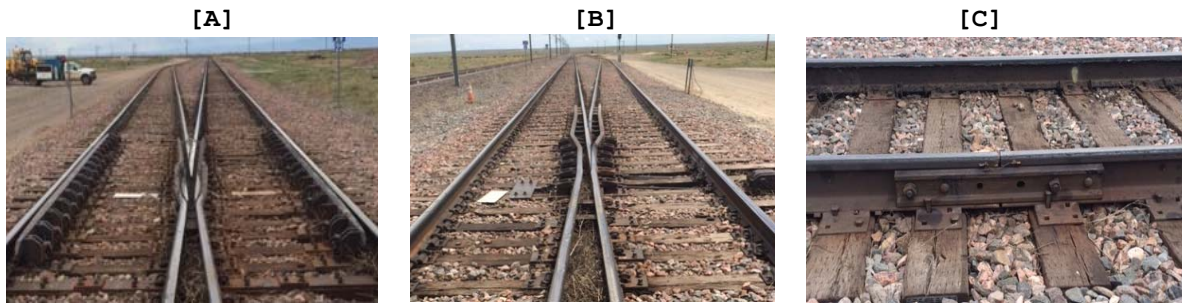
Figure 12. Turnout and frog, switch left [A] and switch Right [B]; steel bridge [C].

Table 1 lists the features of the TT, some of which are shown in Figure 12 and Figure 13. Fast-train operation is restricted to a maximum 40 miles per hour.

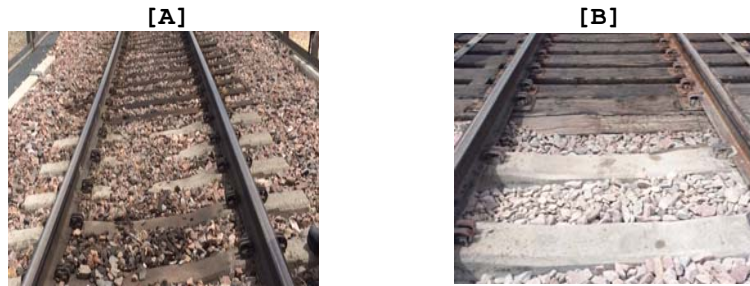
Figure 13: Concrete bridges [A]; crib ties, top of [B]; concrete bridges, bottom of [B].

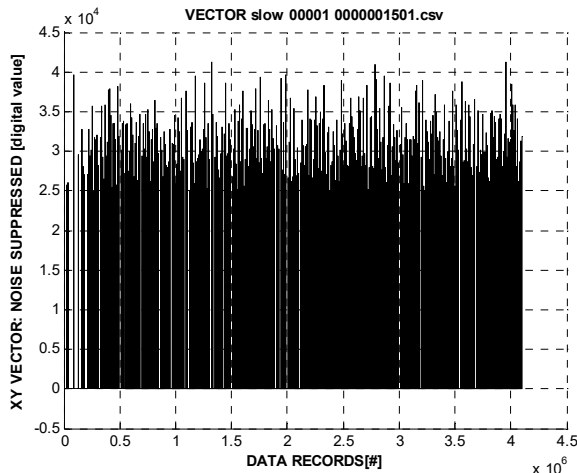
*Data Analysis*—Data analysis was hampered by the loss of Global Positioning Data (GPS) caused by a broken antenna. Consequently, raw data (see Figure 14) was analyzed by binning the data in terms of magnitude (xy-plane, the z-plane, and both planes) and relative laps (see Figure 15), examining the peaks, and comparing those peaks to features of the test track: pattern matching. We successfully proved that, even without GPS, we were able to synchronize the data to the start of the test track and then locate those features that could be located: as seen indicated in Figure 16 and Table 3.

Figure 14. Raw data, xy-plane

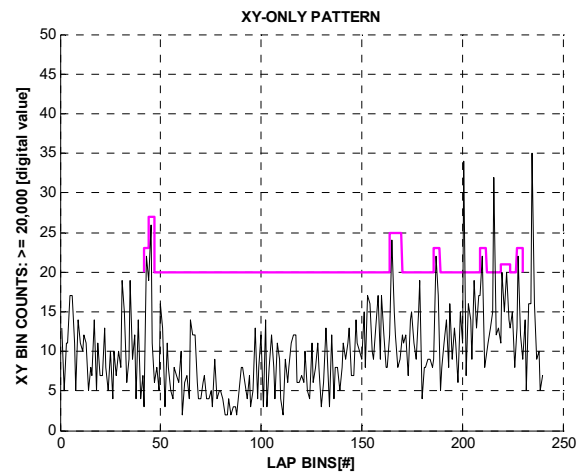
Figure 15. Binned data, xy-plane, by lap-bin number

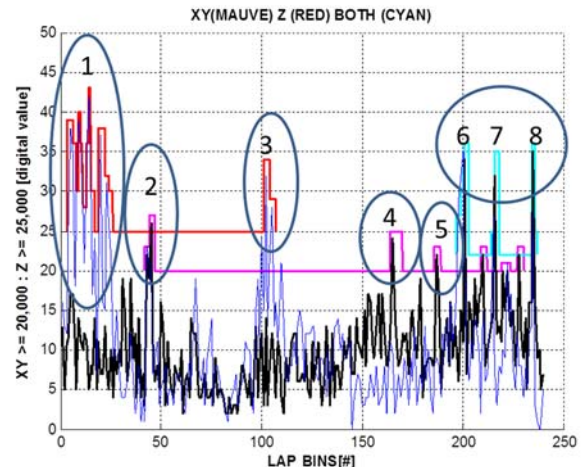
Figure 16. Data and identified features

Track Sections	Feature Sections	TT ID	Track Feature	Detection Evaluation	
				XY-vector	Z-vector
1 – 3		S1	Lubricator	ND	ND
4 – 5		S2			
6 – 62	5-26	S3	Repair/overlay welds		Yes (1)
	30-40	S3	Concrete bridge	maybe	maybe
	42-46	S3	Concrete bridge	maybe	Yes (2)
63 – 66		S4	Steel bridges	ND	ND
67 – 69		S5	Bridge deflection	ND	ND
70 – 73		S6	Steel bridges	ND	ND
74 – 92		S7	Rail performance	ND	ND
93 – 97		S8	Fiber optic cable	ND	ND
98 – 108		S9	405 turnout/frog		Yes (3)
109 – 117		S23	405 turnout/frog		Yes (3)
118 – 125		S24	Lubricator	ND	ND
126 – 163		S25	TPO, Tie and fastener, performance	Yes (4)	
164 – 170		S26			
171 – 175		S27	Lubricator	ND	ND
176 – 180		S28	Turn out, steering switch, foundation	Yes (5)	
181 – 193		S29	LTM Tests	ND	ND
194 – 198		S30			
199 – 208		S31	FRA: Rail-seat deterioration, Thermite welds	Yes (6)	Yes (6)
209 – 212		S32			
213 – 225		S33	Crib ties	Yes (7)	Yes (7)
226 – 229		S34			
230 – 240		S35	407 turnout	Yes (8)	Yes (8)

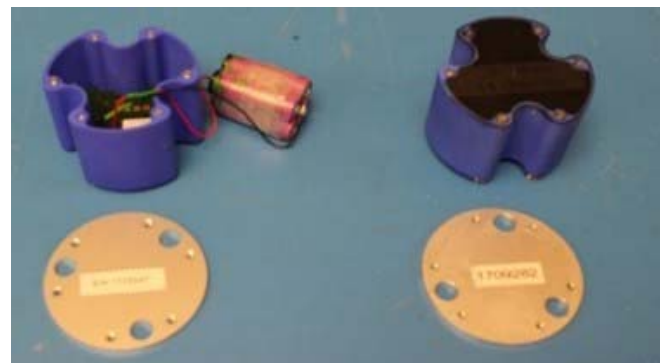
Final testing of the improved MEMS-based sensor, see Figure 17, was performed at the National Technical Systems (NTS) test facilities in Tempe, Arizona and at Ridgetop Group laboratories in Tucson, Arizona.

**Figure 17. Original (left) and improved (right) sensors**

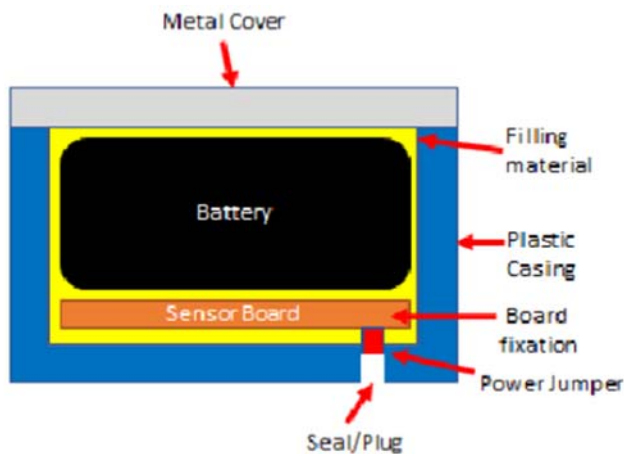
*Component Repositioning*—Experiments were performed using variations of component placement: the highest quality signals were obtained using the component placement shown in Figure 18.

**Figure 18. Component placement diagram**

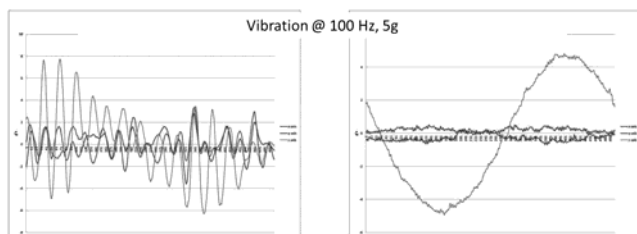
After potting and repositioning of components, the signal quality is significantly improved as seen in Figure 19 through Figure 22.

**Figure 19. Vibration @ 100 Hz, 5g – before (left) and after (right) repositioning and potting**

The output signals from the MEMS-based sensor after repositioning and potting of the boards and battery pack no longer exhibit extreme harmonic distortion and the amplitudes more accurately reflect the magnitude of the vibration force.

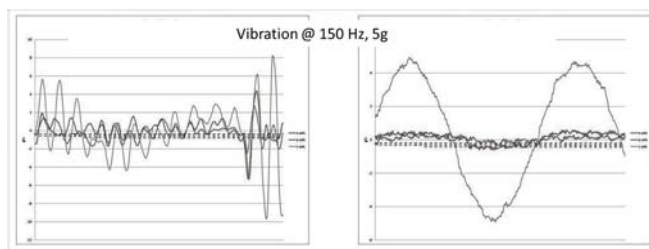
**Figure 20. Vibration @ 150 Hz, 5g – before (left) and after (right) repositioning and potting**

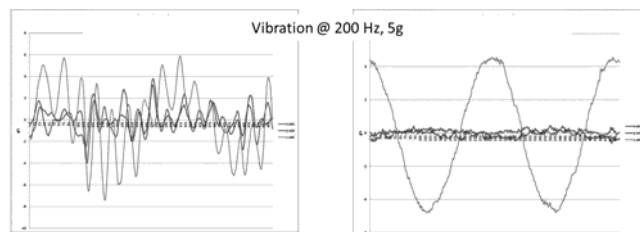
**Figure 21. Vibration @ 200 Hz, 5g – before (left) and after (right) repositioning and potting**

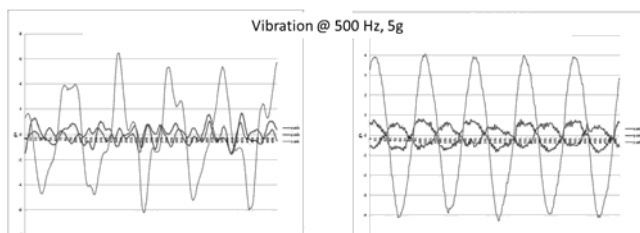
**Figure 22. Vibration @ 500 Hz, 5g – before (left) and after (right) repositioning and potting**
