Evaluation of MEMS-Based Wireless Accelerometer Sensors in Detecting Gear Tooth Faults in Helicopter Transmissions

David G. Lewicki
Glenn Research Center
Cleveland, Ohio 44135

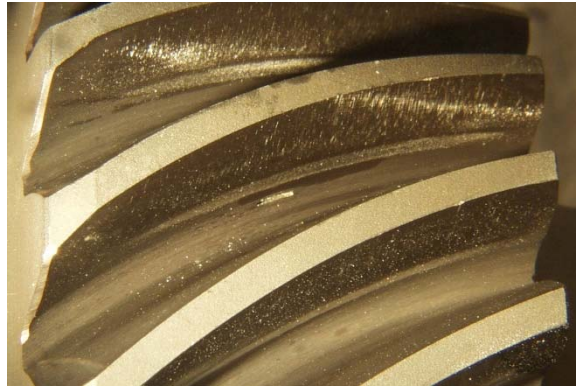
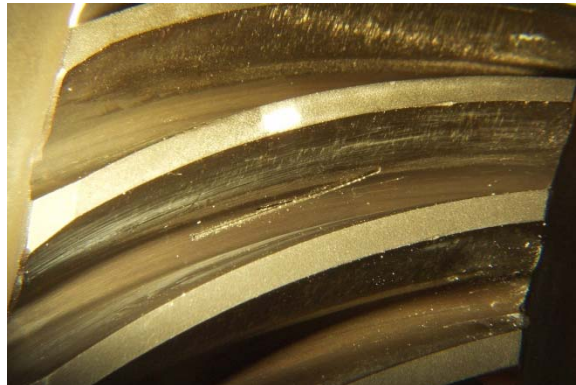
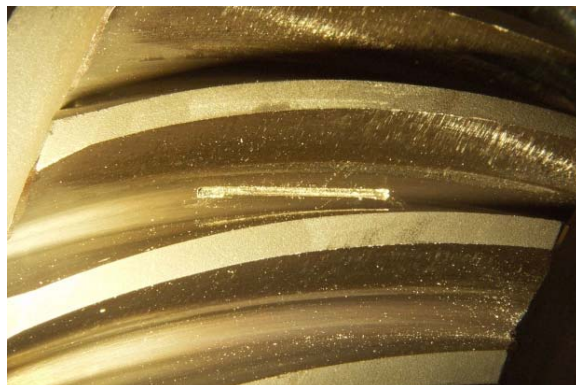
The test article for this study was the spiral-bevel pinion gear. At the start of the test, a 0.01-in long x 0.03-in deep x 0.005-in wide notch was fabricated in the fillet region (loaded side) of one pinion tooth using the electric discharge machining (EDM) process. The purpose of the notch was to introduce a stress concentration in the tooth fillet and promote a bending fatigue failure of the gear tooth during prolonged running. The desired location of the notch was on the fillet radius of the tooth where a large tensile bending stress occurs during gear tooth engagement. The actual location of the notch (Fig. 3a) was a little lower than desired, biased toward the root of the gear. After 51.86 hours of run time (described later in the paper), the gear tooth did not initiate bending fatigue and the original notch was extended to 0.5-in long x 0.045-in deep x 0.005-in wide (Fig. 3b). This notch, however, was slightly misaligned to the tooth fillet and the ends of the notch were not located at the high stress regions. After 106.11 cumulative hours of run time, the gear tooth did not initiate bending fatigue and an additional notch, 0.5-in long x 0.045-in deep x 0.005-in wide, was fabricated using EDM on a second tooth (Fig. 3c). This notch was oriented in the high stress fillet region as desired, and bending fatigue occurred after 112.36 cumulative hours run time.

It was observed that the widened notch on the pinion was slightly misaligned to the tooth fillet and the ends of the notch were not located at the high stress regions. Thus, an additional notch, 0.5-in long x 0.045-in deep x 0.005-in wide, was fabricated on a second tooth. Testing resumed at 4339 in-lb input torque and increased to 4649 in-lb at 110.17 cumulative hours. At 112.30 hours, a fractured spiral-bevel pinion tooth was observed from the proximity probe data. The endurance tests concluded at 112.36 cumulative hours. The transmission was disassembled and the fractured pinion tooth occurred at the second notch location (Fig. 11), which was correctly oriented in the high fillet stress region.

Fig. 3. Fabricated notches on OH-58C spiral-bevel pinion gear teeth.

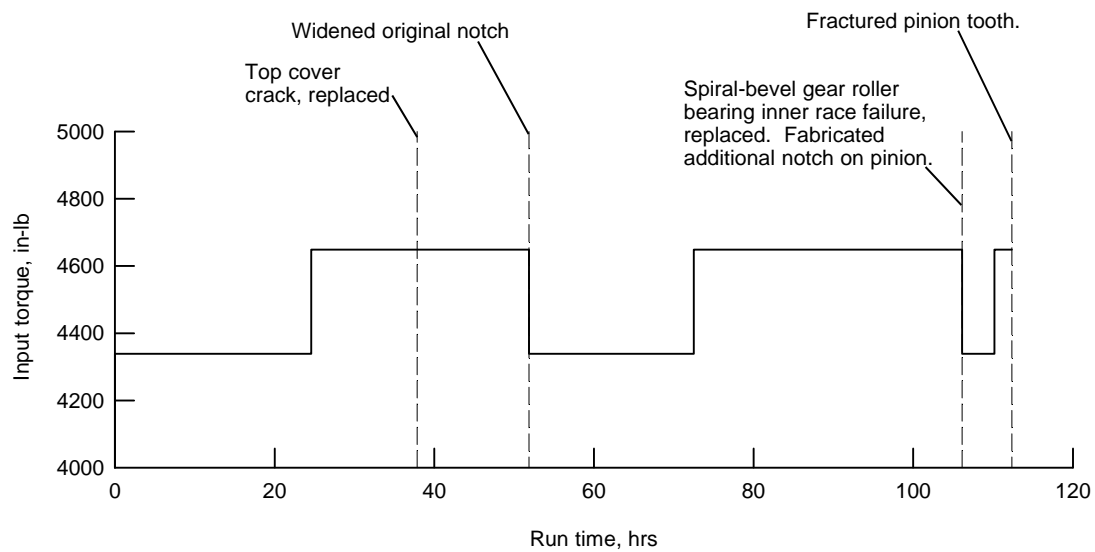
Test summary. Fig. 10 shows the timeline of the OH-58C endurance tests, displaying the transmission input torque versus run time for the entire test. All tests were run at full input speed of 6180 rpm. The entire test lasted 112.36 hours spanning 24 days. As previously mentioned, a 0.01-in long x 0.03-in deep x 0.005-in wide notch was fabricated in the fillet region (loaded side) of one pinion tooth at the start of the test. This condition was run for 24.59 hours at 4339 in-lb input torque (127% design). At no sign of failure, the torque was increased to 4649 in-lb (136% design). During this time, a crack occurred on the OH-58C top cover housing at 37.84 cumulative hours. This failure had no bearing on the pinion endurance tests, and a replacement cover was installed on the transmission and testing resumed. At 51.86 cumulative hours, no failure of the pinion occurred. Upon inspection, the actual location of the notch was a little lower than desired, biased toward the root of the gear. Due to this, the stress concentration on the notched pinion tooth was less than desired and no failure occurred. The original notch was extended to 0.5-in long x 0.045-in deep x 0.005-in wide. Testing resumed at 4339 in-lb input torque. At 72.51 cumulative hours, no failure occurred and the torque was increased to 4649 in-lb. During this period, indication of chips and debris were observed and testing was stopped at 106.11 cumulative hours. The transmission was disassembled, inspected, and a fatigue spall failure was discovered on the spiral-bevel gear roller bearing inner race. A replacement bearing was installed.

Fig. 10. Timeline of spiral-bevel pinion endurance tests.

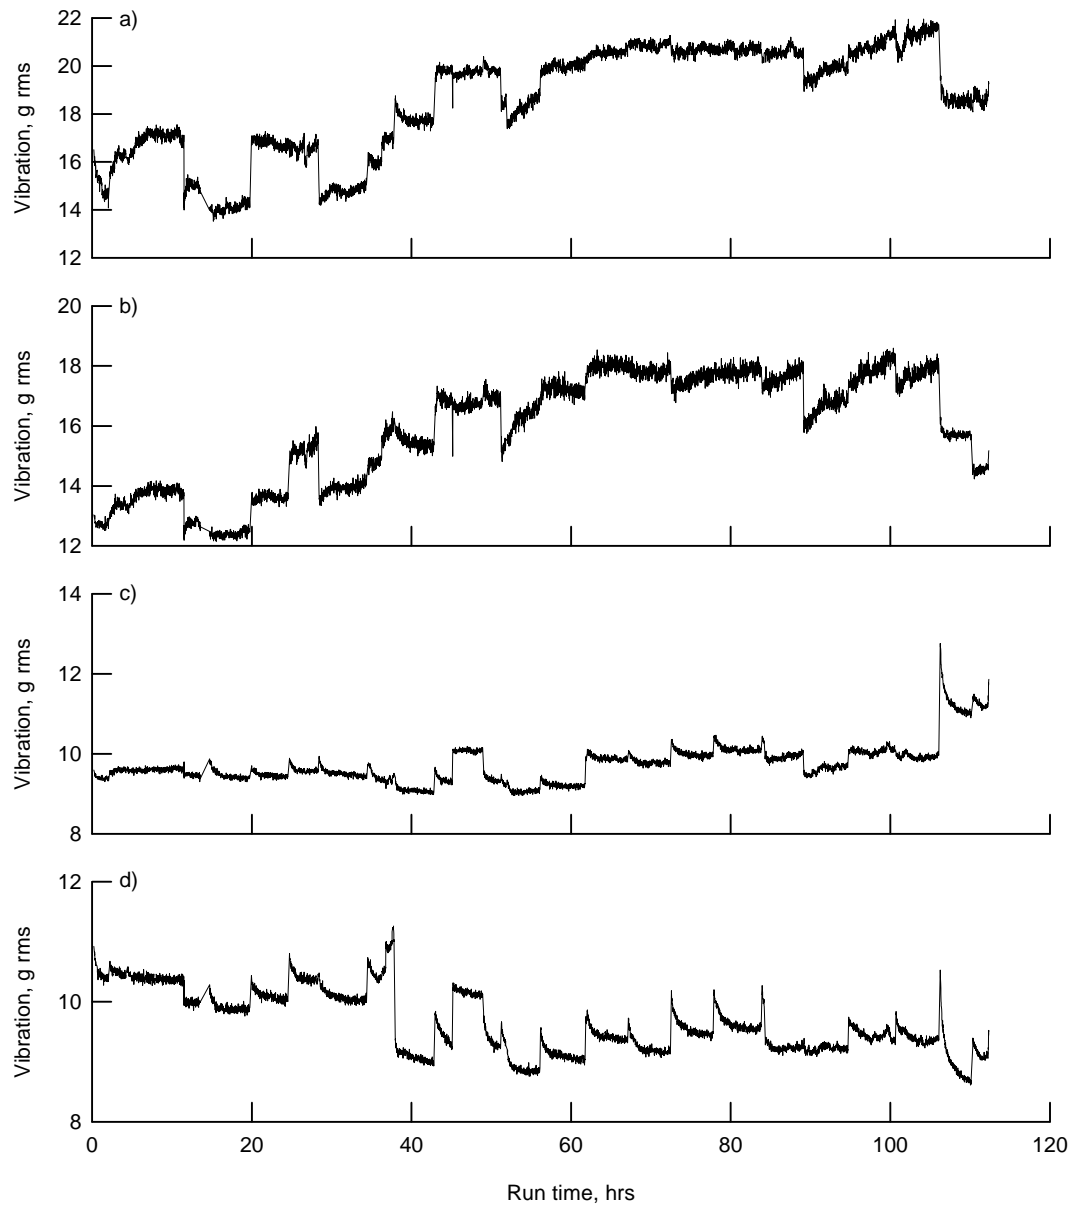
Fig. 12. RMS of MDSS raw vibration for entire test. a) Accelerometer A1, bevel pinion vertical. b) Accelerometer A2, bevel pinion horizontal. c) Accelerometer A3, ring gear. d) Accelerometer A4, ring gear.

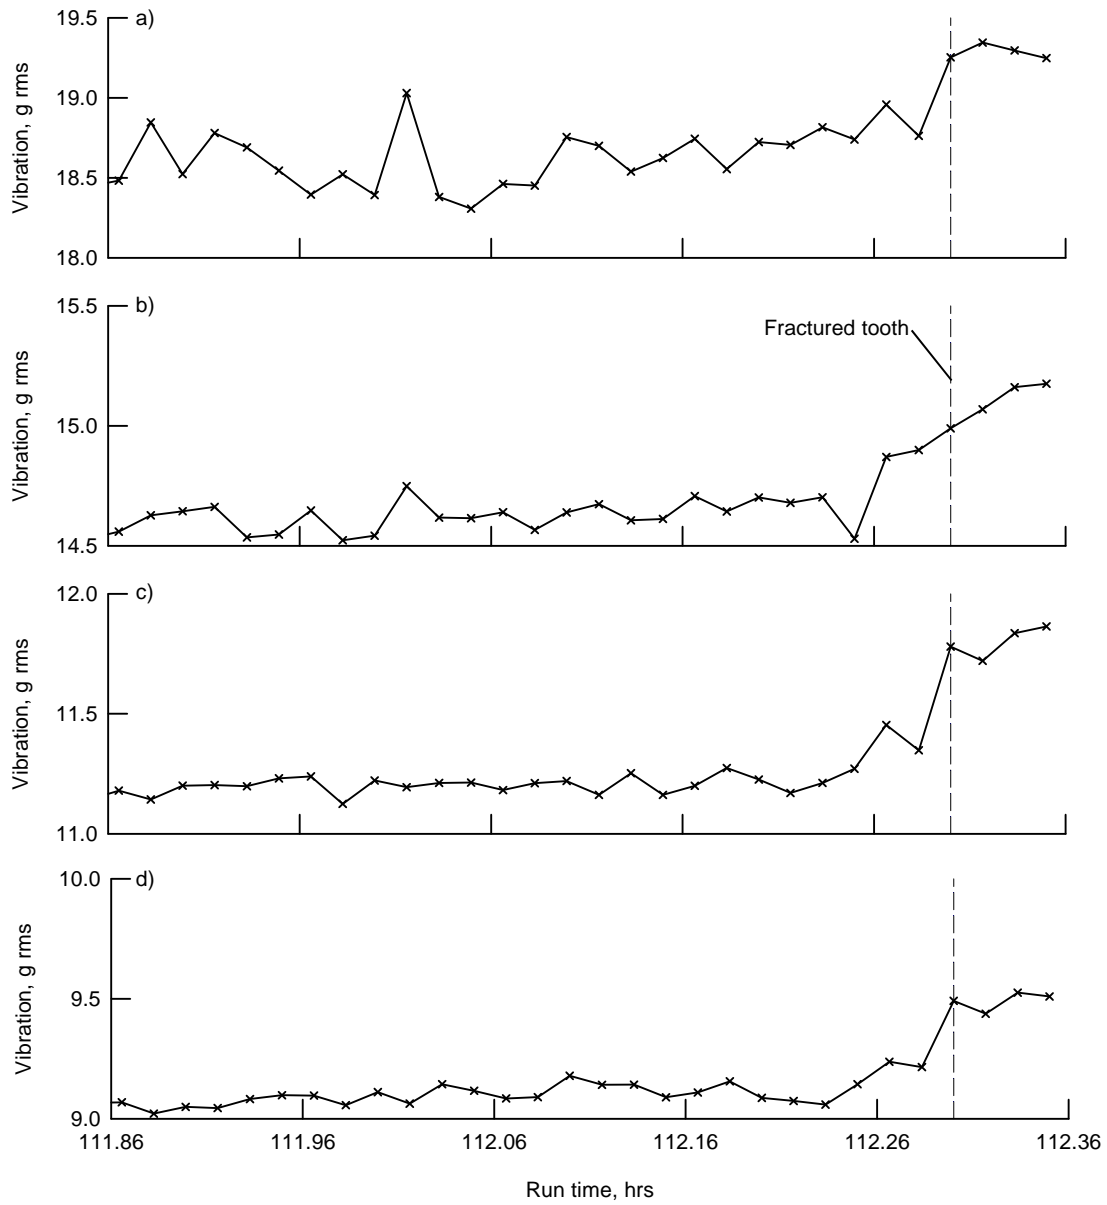
Fig. 13. RMS of MDSS raw vibration for last 30 minutes of test. a) Accelerometer A1, bevel pinion vertical.

b) Accelerometer A2, bevel pinion horizontal. c) Accelerometer A3, ring gear. d) Accelerometer A4, ring gear.

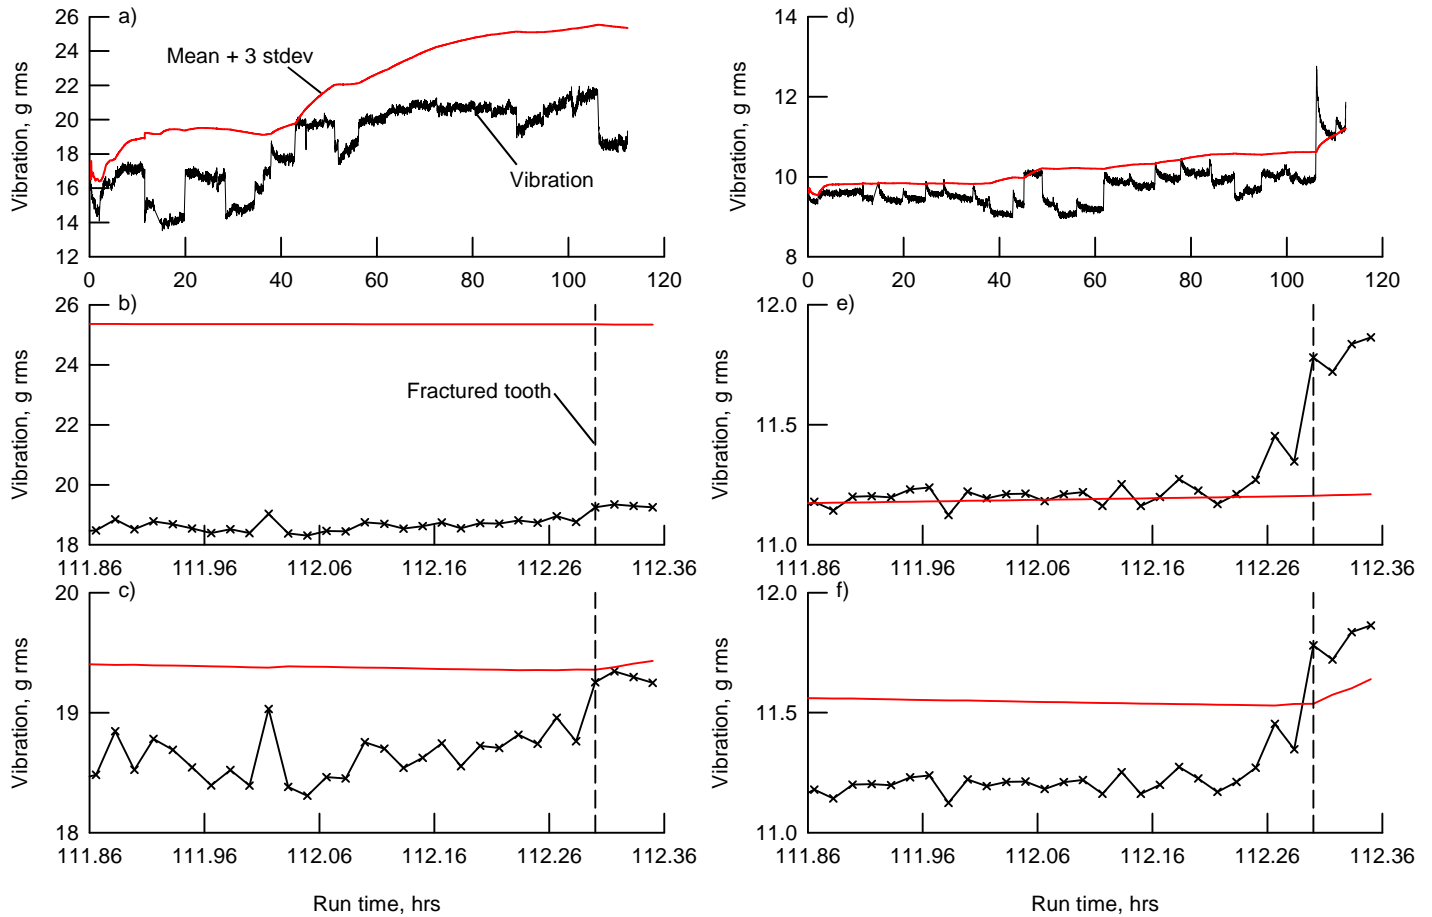
Fig. 14. Evaluation of fault detection capability, RMS of MDSS raw vibration.

a) Accelerometer A1, entire test.
b) Accelerometer A1, last 30 minutes of test.
c) Accelerometer A1, last 30 minutes of test, mean and standard deviation
   evaluated for last day of test only.

d) Accelerometer A3, entire test.
e) Accelerometer A3, last 30 minutes of test.
f) Accelerometer A3, last 30 minutes of test, mean and standard deviation
   evaluated for last day of test only.

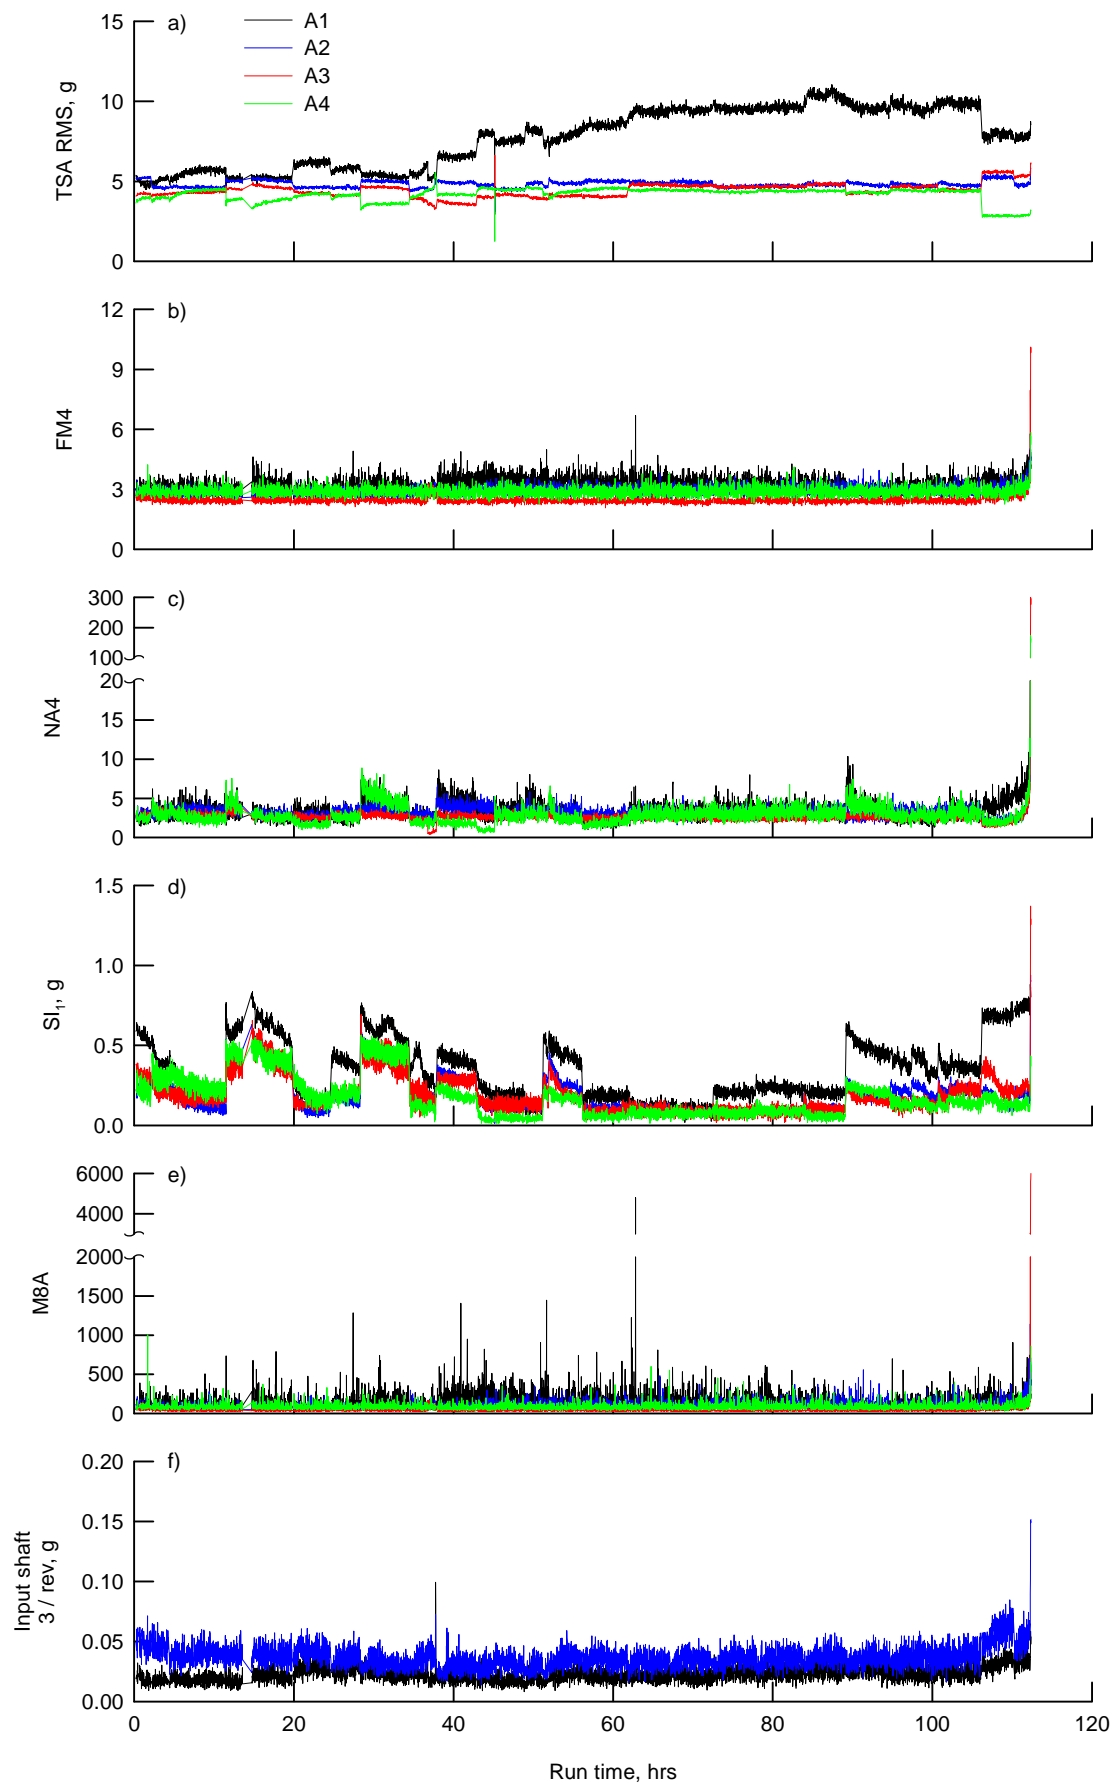
Fig. 15. MDSS fault detection condition indicators for entire test.

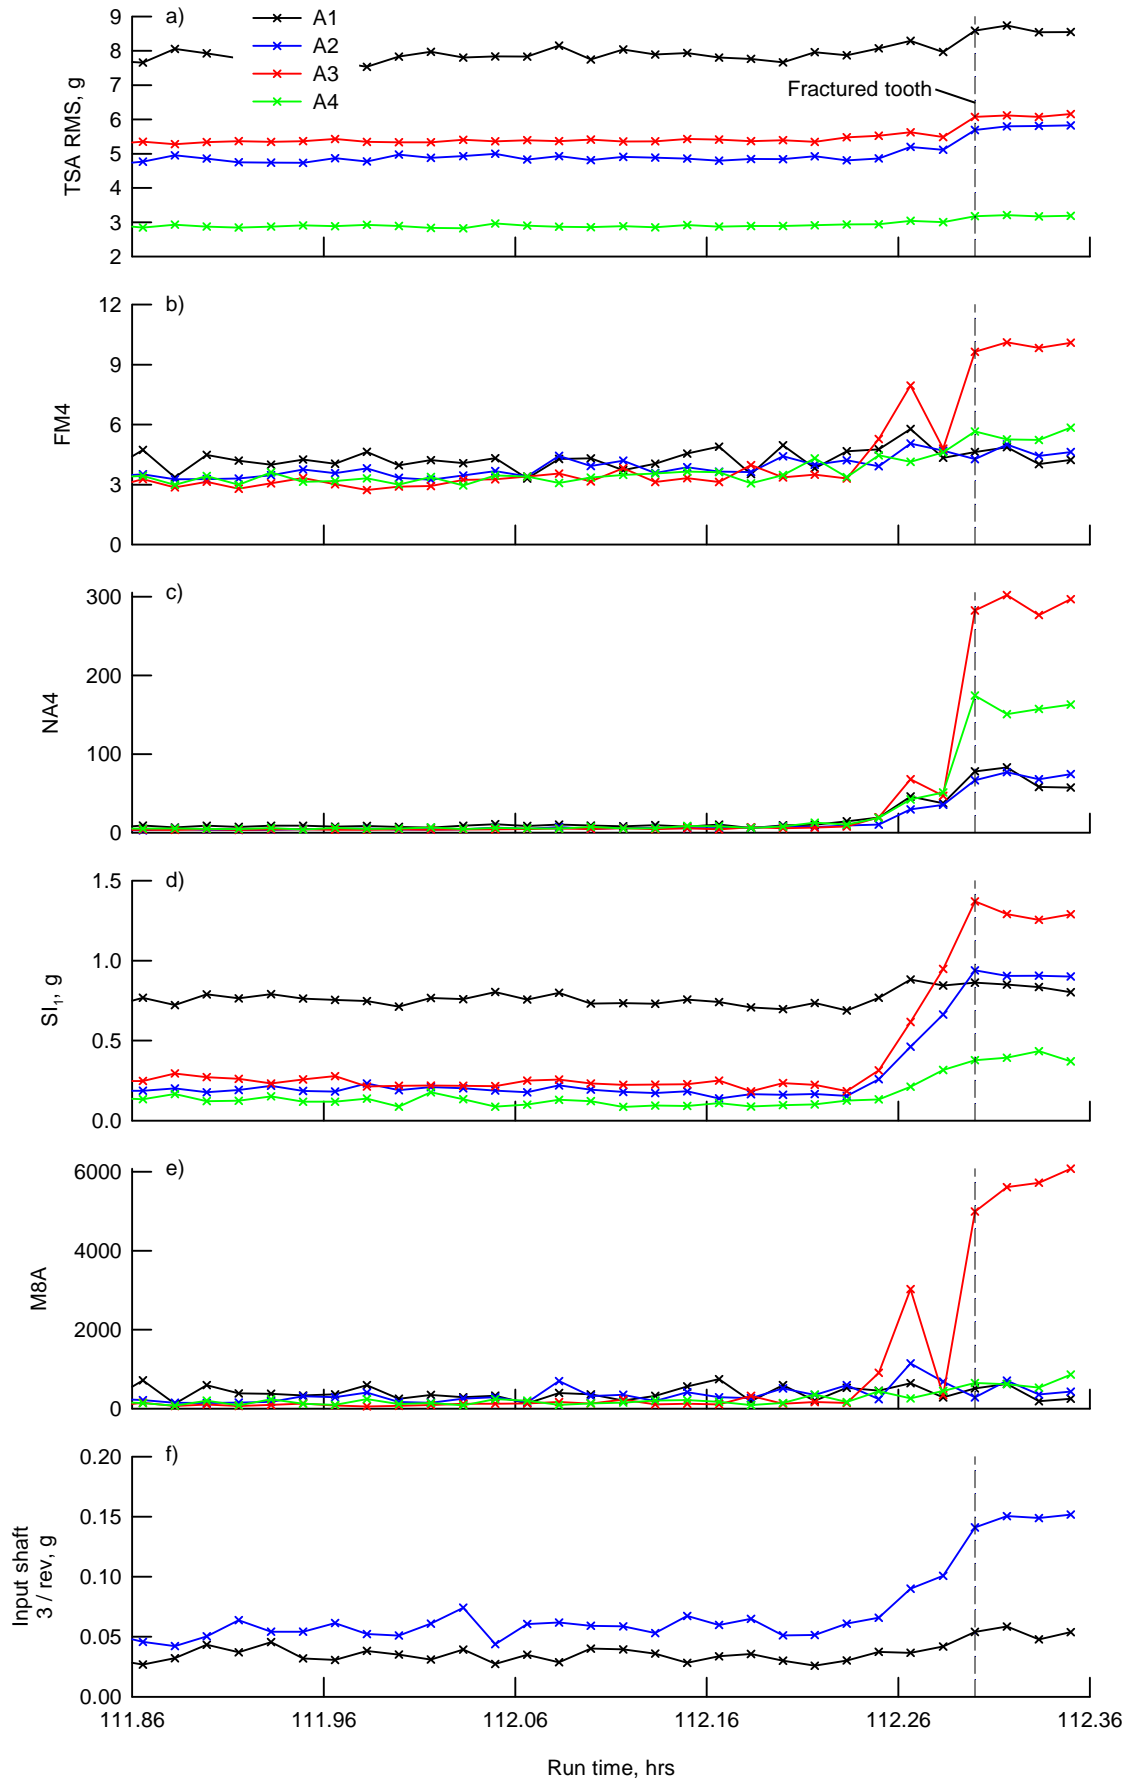
Fig. 16. MDSS fault detection condition indicators for last 30 minutes of test.

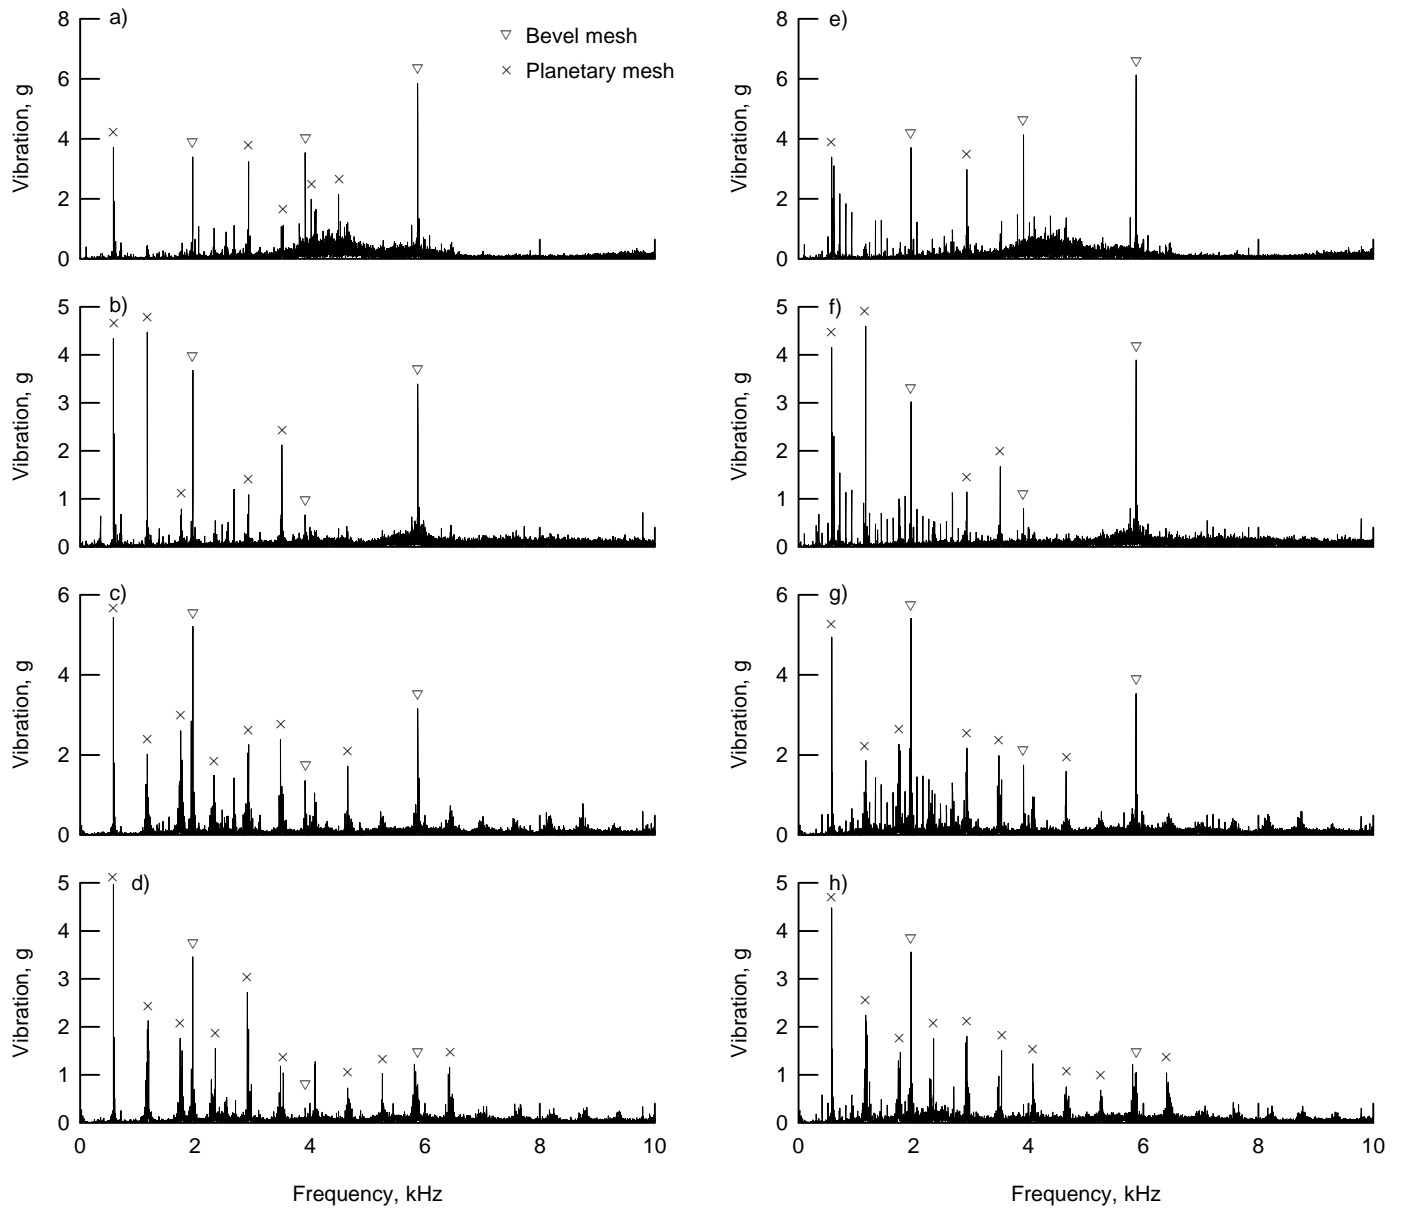
Fig. 17. MDSS sample spectrums. a) Accelerometer A1 at run time 110.50 hrs. b) Accelerometer A2 at run time 110.50 hrs. c) Accelerometer A3 at run time 110.50 hrs. d) Accelerometer A4 at run time 110.50 hrs. e) Accelerometer A1 at run time 112.35 hrs. f) Accelerometer A2 at run time 112.35 hrs. g) Accelerometer A3 at run time 112.35 hrs. h) Accelerometer A4 at run time 112.35 hrs.

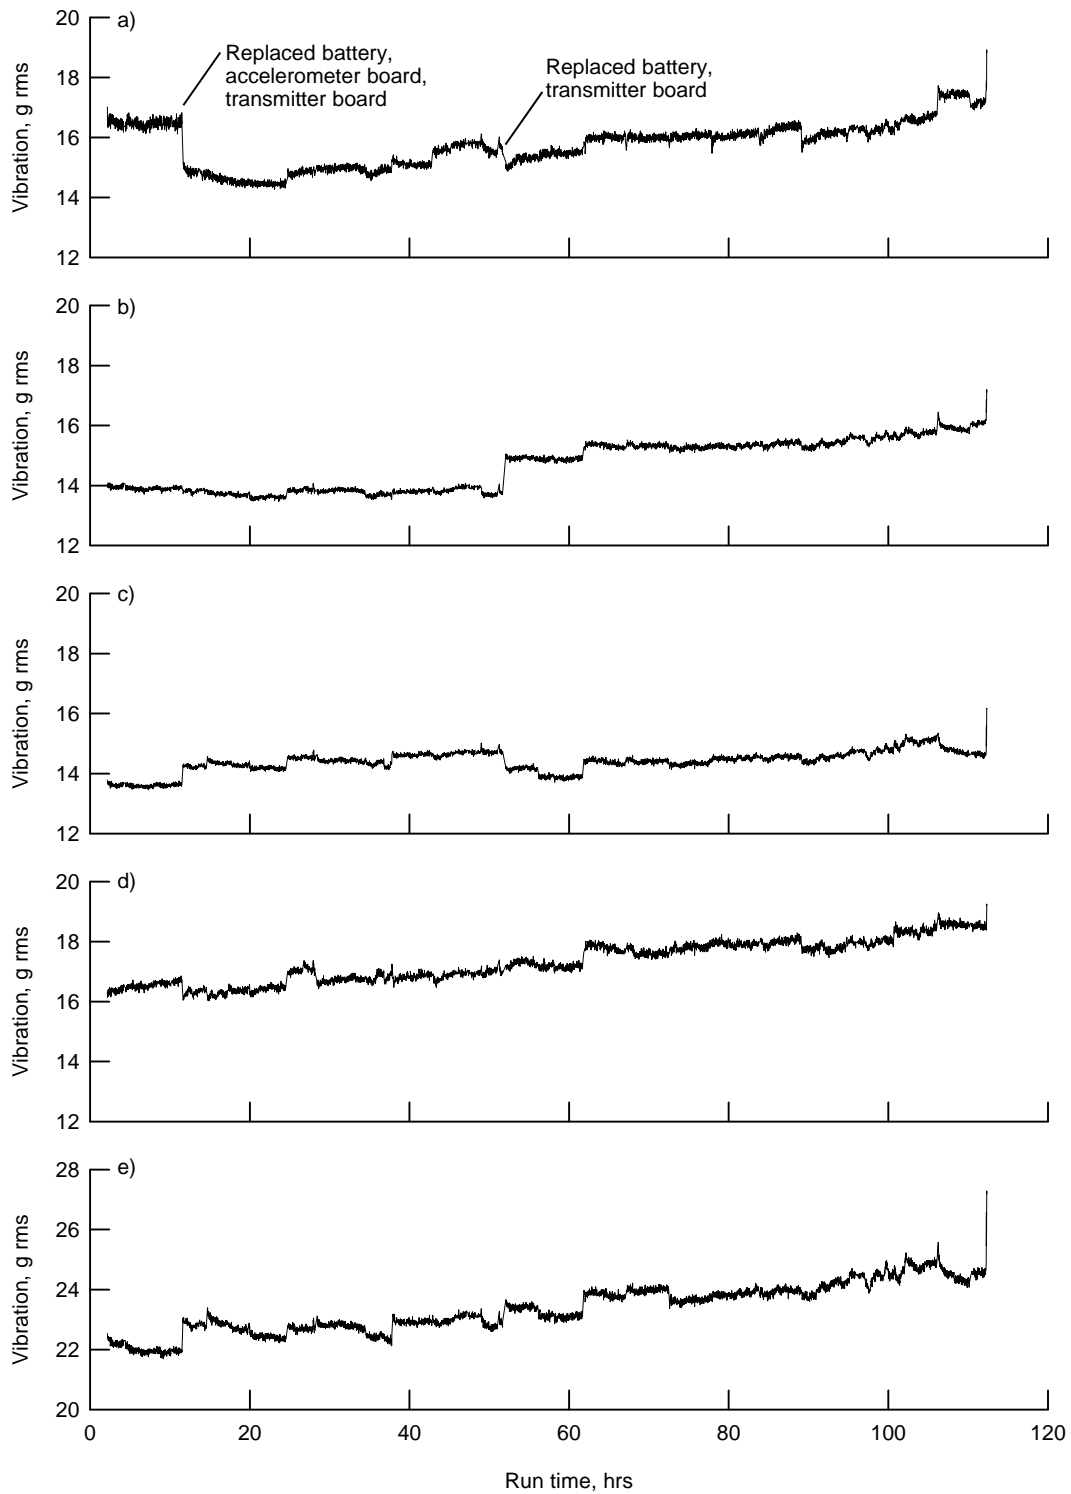
MEMS results. Fig. 18 shows the RMS of the raw broadband vibration for the MEMS sensors as a function of run time for the entire endurance test. This data was post-processed after completion of the tests. The RMS values for each of the three MEMS sensors were calculated for each one-second broadband time acquisition with DC offsets removed. Fig. 18a gives the radial accelerometer, R, Fig. 18b gives the tangential accelerometer, T1, and Fig. 18c gives the tangential accelerometer, T2 (refer to Fig. 7) plotted versus cumulative run time. The radial accelerometer measured radial or lateral motion of the pinion gear shaft. The tangential accelerometers measured radial motion as well as tangential or rotational acceleration of the gear shaft. Adding the signals of the tangential accelerometers (T1+T2, Fig. 18d) results in purely torsional motion since the T1 and T2 accelerometers are positioned at opposite polarity (Fig. 7). Subtracting the signals of the tangential accelerometers (T1-T2, Fig. 18e) results in just radial motion and is similar to the radial accelerometer, R.

Fig. 18. RMS of MEMS raw vibration for entire test. a) Radial accelerometer, R. b) Tangential accelerometer, T1. c) Tangential accelerometer, T2. d) T1+T2, torsional acceleration. e) T1-T2, radial acceleration.

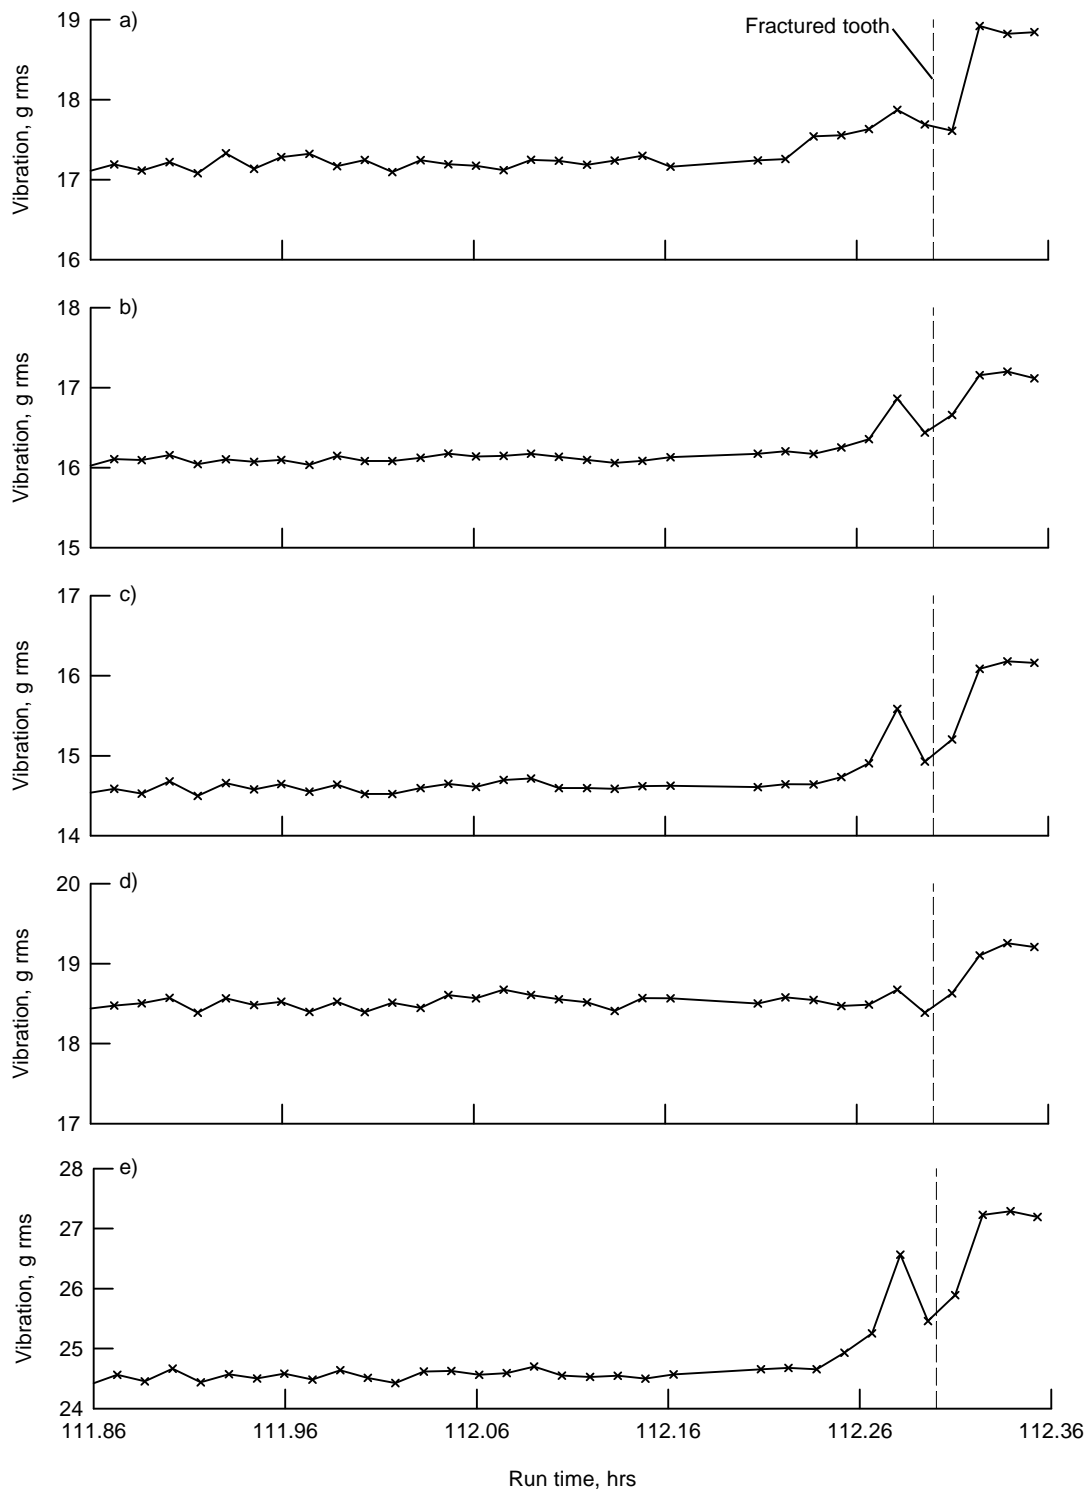
Fig. 19 shows the same data as Fig. 18, but expanded for only the last 30 minutes of test. From the RMS, all three accelerometers (R, T1, and T2) gave an indication of failure at the end of the test (Figs. 19a, 19b, and 19c). Based on the statistical definition previously defines, accelerometers R and T2 fully detected failure and accelerometer marginally detected failure using the running average for the entire test and all accelerometers fully detected failure using the running average of only the last day. As with the MDSS data, the MEMS sensors did not respond much sooner than the actual tooth fracture time.

Fig. 19. RMS of MEMS raw vibration for last 30 minutes of test. a) Radial accelerometer, R. b) Tangential accelerometer, T1. c) Tangential accelerometer, T2. d) T1+T2, torsional acceleration. e) T1-T2, radial acceleration.

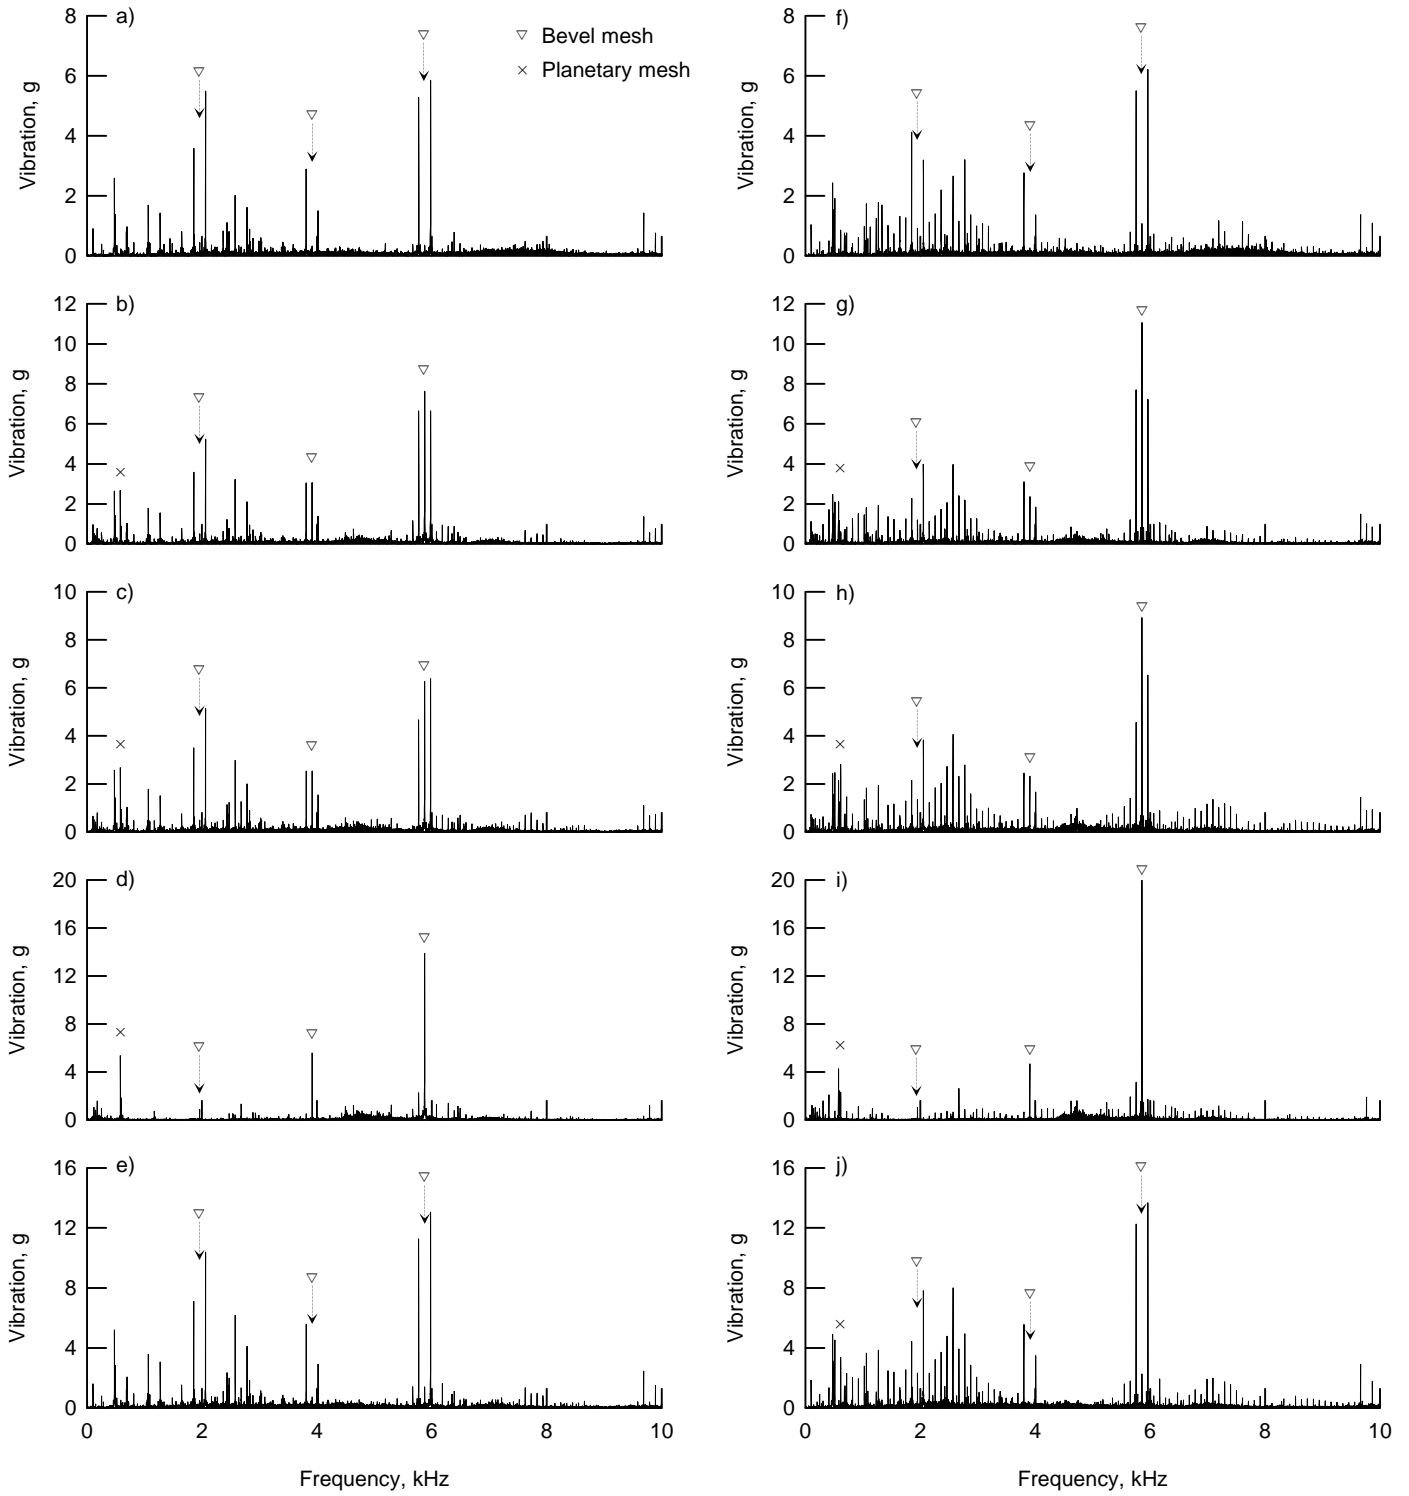
To gain insight of the MEMS vibration data, Fig. 20 shows spectra plots at two run times toward the end of the test. The first run time was at 110.49 hours (left column, Figs. 20a - 20e). This was at the start of the last day of testing. The second time was at 112.35 hours (right column, Figs. 20f - 20j) and was the last data point taken for the test, which occurred after pinion tooth fracture. All data were at 6180 rpm transmission input speed and 4649 in-lb input torque.

Thus, the vibration for the spiral-bevel gear mesh will not occur at the mesh frequencies, f_m, but at the sideband frequencies f_m+f_s and f_m-f_s, where f_s is the shaft frequency. The spectrum for the radial accelerometer in Fig. 20a illustrates this phenomenon. Vibration did not occur at the spiral-bevel mesh frequencies, 1957 (meshing frequency), 3914 (1st harmonic), and 5871 (2nd harmonic) Hz. They occurred at $1957 \pm 103 = 1854$ and 2060 Hz (meshing frequencies), $3914 \pm 103 = 3811$ and 4017 Hz (1st harmonic), and $5871 \pm 103 = 5768$ and 5974 Hz (2nd harmonic), where the shaft frequency was 103 Hz.

For the tangential accelerometers, radial motion and tangential motion are measured. The torsional motion will cause vibration directly at the gear meshing frequencies since this motion follows the rotating measurement position. The radial motion will cause the sidebands as described above. Figs. 20b and 20c show this where vibration spikes occur at 3811, 3914, 4017, 5768, 5871, and 5974 Hz for the spiral-bevel mesh second and third harmonic frequencies. It is interesting to note that there is no torsional vibration at the spiral-bevel meshing frequency of 1957 Hz. Accelerometers T1 and T2 gave very similar responses. Fig. 20d depicts the vibration from T1+T2, which is the torsional acceleration. Here, the radial/lateral portion is cancelled out, and thus, vibration occurred at the gear meshing frequencies and not the sidebands as in R, T1, and T2. Fig. 20e shows the vibration from T1-T2. Here, the torsional portion is cancelled out and the response is similar to the radial accelerometer from Fig. 20a.

For the data before tooth failure (Fig. 20 left column), the majority of the vibration energy occurred at the spiral-bevel mesh, harmonic, and sideband frequencies (triangles in the figures). Only a small amount of energy occurred at the planetary mesh frequencies (cross in figures) since the MEMS sensing package was installed directly on the rotating spiral-bevel pinion gear shaft. After tooth fracture (right column), the overall energy at the spiral-bevel and planetary mesh fundamental and harmonic frequencies was similar (same vertical scale in figures between left and right columns). However, much increased energy occurred through the complete spectrum, with an emphasis on sidebands at multiples of the bevel gear shaft frequency. This was the reason the RMS indicator on the overall broadband signal did detect tooth failure.

Fig. 20. MEMS sample spectrums. a) Radial accelerometer, R, at run time 110.49 hrs. b) Tangential accelerometer, T1, at run time 110.49 hrs. c) Tangential accelerometer, T2, at run time 110.49 hrs. d) T1+T2 at run time 110.49 hrs. e) T1-T2 at run time 110.49 hrs. f) R at run time 112.35 hrs. g) T1 at run time 112.35 hrs. h) T2 at run time 112.35 hrs. i) T1+T2 at run time 112.35 hrs. j) T1-T2 at run time 112.35 hrs.

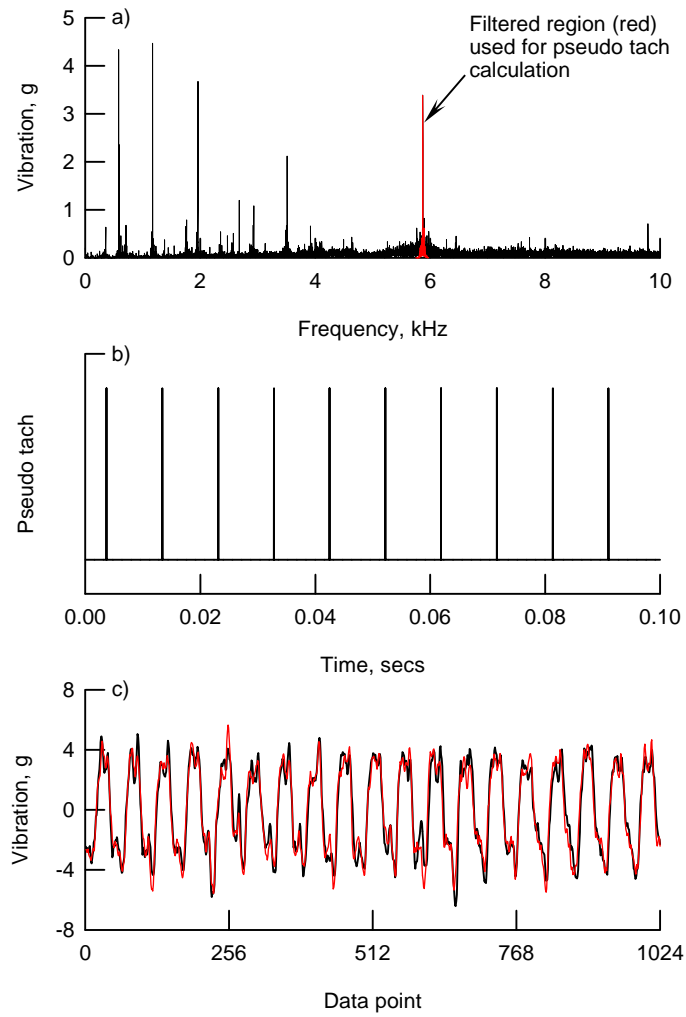
First, this method was applied to MDSS data to compare the TSA calculated from the pseudo tach signal to that calculated from the actual tach signal. Fig. 21a shows a sample spectrum from MDSS accelerometer A2 at run time 110.50 hours (same data as in Fig. 17b). The black data is the spectrum

from the raw time signal and the red data is the spectrum from the filtered signal used for the pseudo tach calculation. The red data was filtered around 5872 Hz, which was the 3rd harmonic of the spiral-bevel mesh. Fig. 21b shows the calculated pseudo tach from the zero-crossings routine. The mean calculated speed from the pseudo tach data was 6182 rpm, which correlated exactly with that from the facility data acquisition speed sensor. Fig. 21c compares the TSA's. The black data is the MDSS-calculated TSA using the measured tach signal. The red data is the TSA using the pseudo tach signal. As seen in the figure, good correlation between the TSA using the measured tach signal to that using the pseudo tach signal is seen.

Fig. 21. Sample pseudo tach calculation results using MDSS data at run
time 110.50 hrs. a) Spectrum from accelerometer A2. b) Calculated
pseudo tach. c) Time synchronous averages (black: MDSS tach,

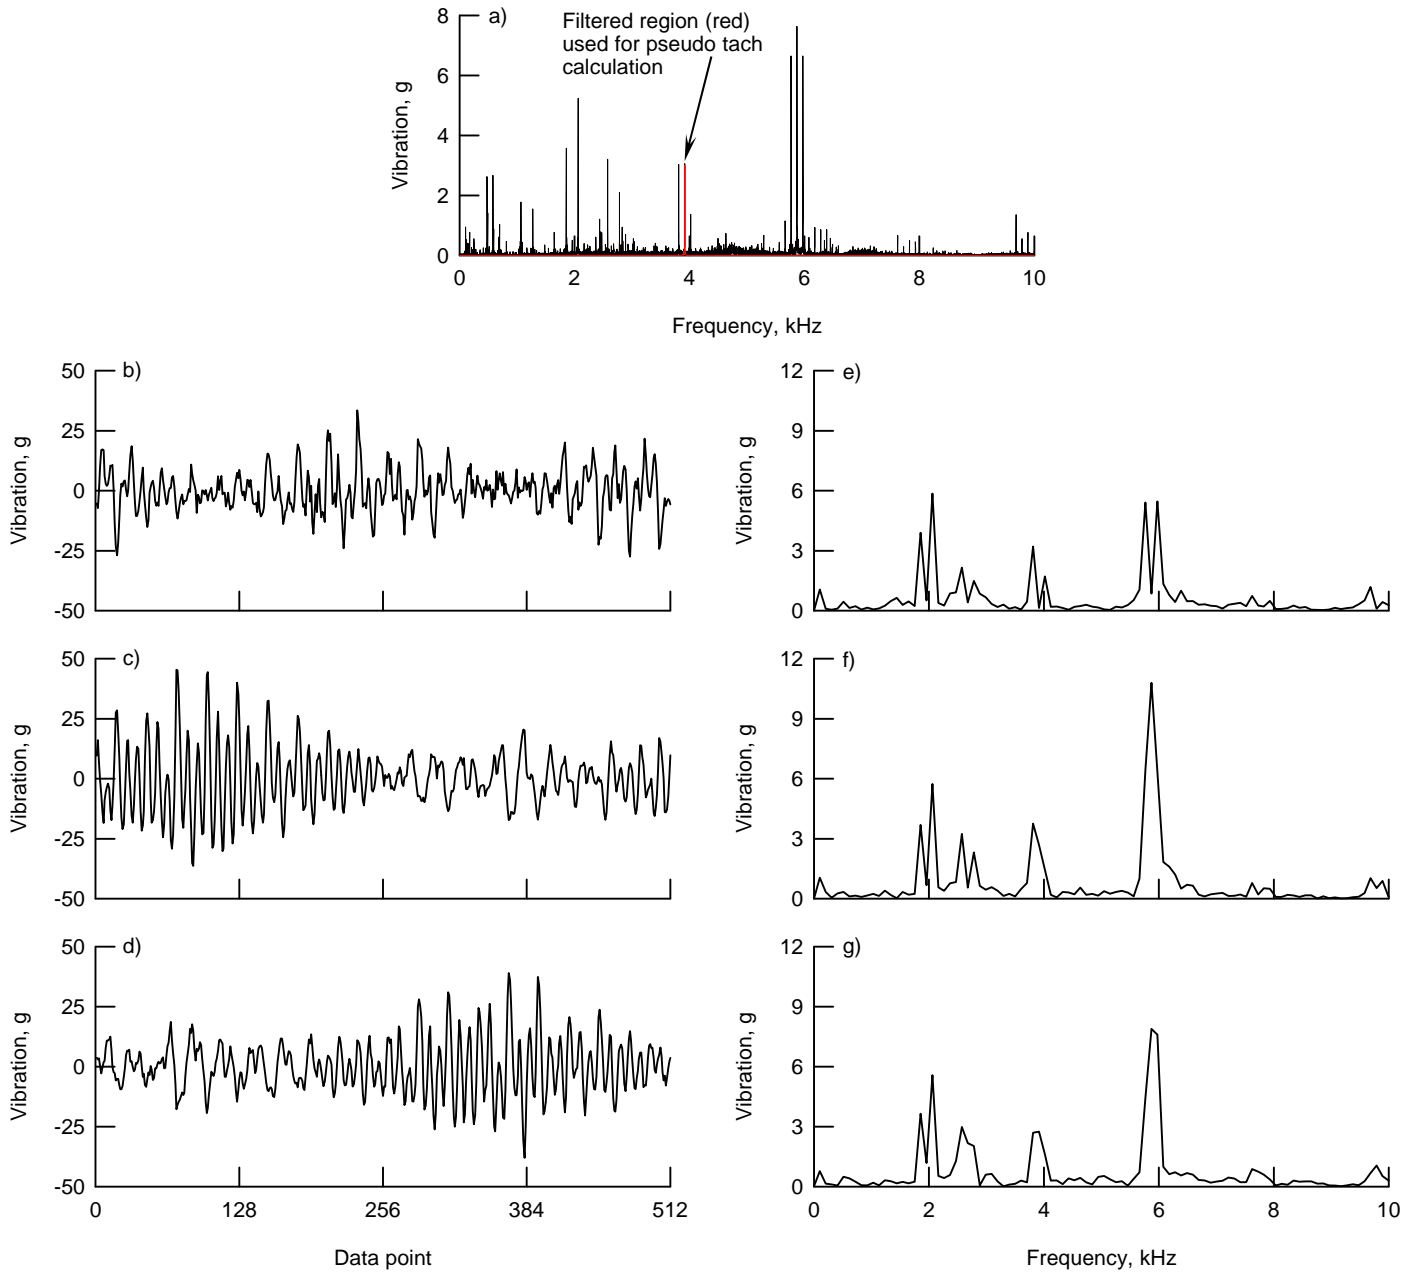
Fig. 22 shows a sample TSA from the MEMS data at run time 110.49 hours. Tangential accelerometer T1 was used to extract the pseudo tach signal and Fig. 22a shows the spectrum. The filtered data around 3915 Hz (spiral-bevel mesh 2nd harmonic frequency) was used because it was the cleanest gear harmonic. Figs. 22b through 22d depict the TSA's for accelerometers R, T1, and T2, respectively. Figs. 22e through 22g shows the spectrums of the TSA's. For this example, a relatively large once-per-revolution oscillation occurred. The period of the TSA signal was one gear shaft rotation. A total of 512 interpolated point were used for the TSA. This gave a bandwidth of one shaft order (103 Hz) in the frequency domain. As expected, energy is seen around the spiral-bevel gear mesh fundamental and harmonics frequencies, with higher activity at the 2nd and 3rd harmonics. Similar results were obtained when accelerometer T2 was used to extract the pseudo tach signal. Radial accelerometer R could not be used to extract the pseudo tach signal since it did not exhibit strong energy directly at any gear mesh harmonic frequency.

Fig. 22. Sample time synchronous average calculation results using MEMS data at run time 110.49 hrs. a) Spectrum from accelerometer T1, used for pseudo tach calculation. b) TSA, radial accelerometer, R. c) TSA, tangential accelerometer, T1. d) TSA, tangential accelerometer, T2. e) FFT of TSA, radial accelerometer, R. f) FFT of TSA, tangential accelerometer, T1. g) FFT of TSA, tangential accelerometer, T2.
