Evaluation of MEMS-Based Wireless Accelerometer Sensors in Detecting Gear Tooth Faults in Helicopter Transmissions

David G. Lewicki
Glenn Research Center
Cleveland, Ohio 44135

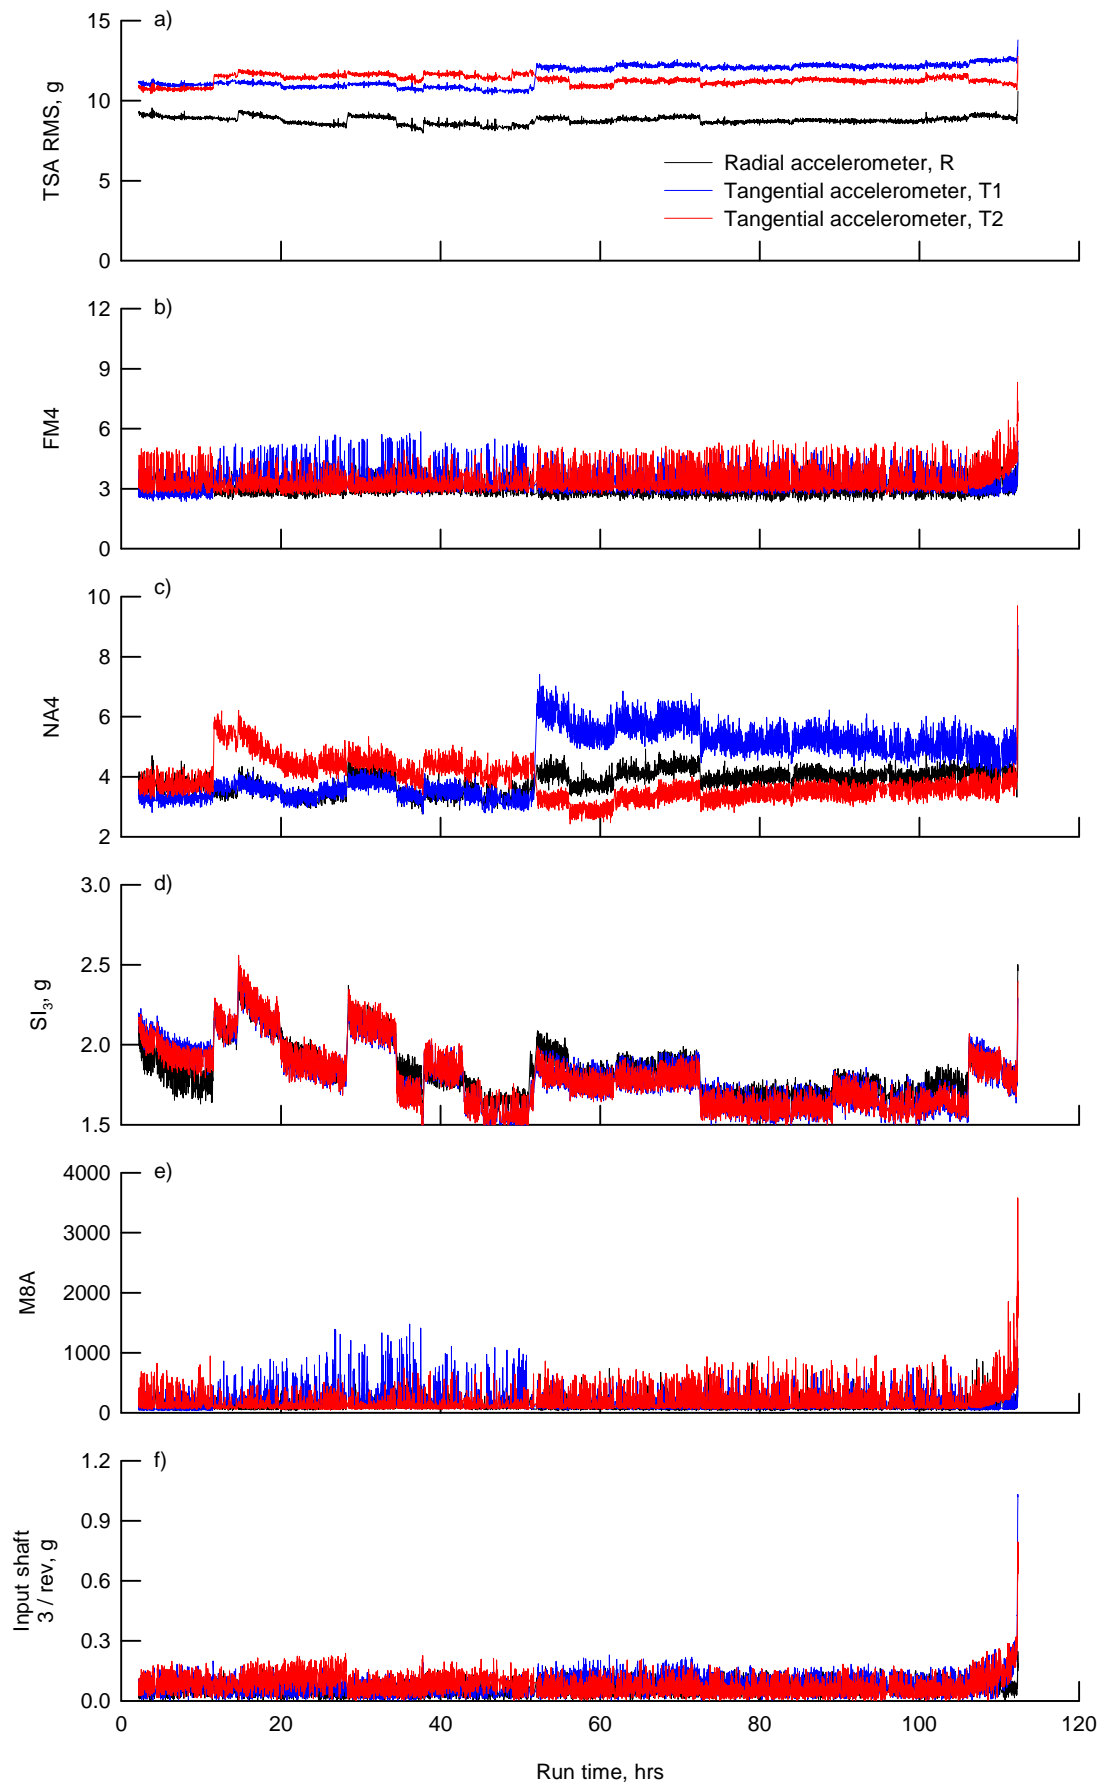
Fig. 23 shows six gear fault detection CI's calculated from the pseudo tach TSA signals of the MEMS data. The CI's are shown as a function of run time for the entire test. These CI's can be compared to those from the MDSS (Fig. 15). Note that SI_3 performed better than SI_1 for the MEMS data and is shown in the results. In general, the MEMS CI's were a little noisier than those from the MDSS, but all exhibited an increase in value at gear tooth failure at the end of the test. Fig. 24 shows the MEMS CI's for the last 30 minutes of the testing. Again, gear tooth failure occurred at 112.30 hrs. Tables III and IV summarize the gear fault detection capabilities for the MEMS indicators. Table III uses the running mean plus three-standard-deviation average for the entire test while Table IV uses the running average for the last day only. All CI's for all accelerometers give an indication of failure when using the running average of only the last day (Table IV). Raw RMS, TSA RMS, NA4, and SI_3 fully detected failure for all accelerometers. Accelerometer T1 performed the best where all CI's fully detected failure. This was probably due to accelerometer T1 being physically closest to the fractured gear tooth (Fig. 7). The method of constructing a pseudo tach signal from periodic characteristics of the vibration data was successful in deriving a TSA signal without an actual tach and proved as an effective way to improve fault detection. As with the MDSS results, the fault detection capability was rated lower when the running average used data from the entire test (Table III) due to increased scatter. The MEMS CI's reacted to the gear failure at a similar time as that from the MDSS data, again, not much sooner than the actual tooth fracture. In comparing the gear fault detection capability of the MDSS to the MEMS (comparing Tables I through IV), the MEMS systems performed as well, if not better, than the MDSS.

Fig. 23. MEMS fault detection condition indicators for entire test.

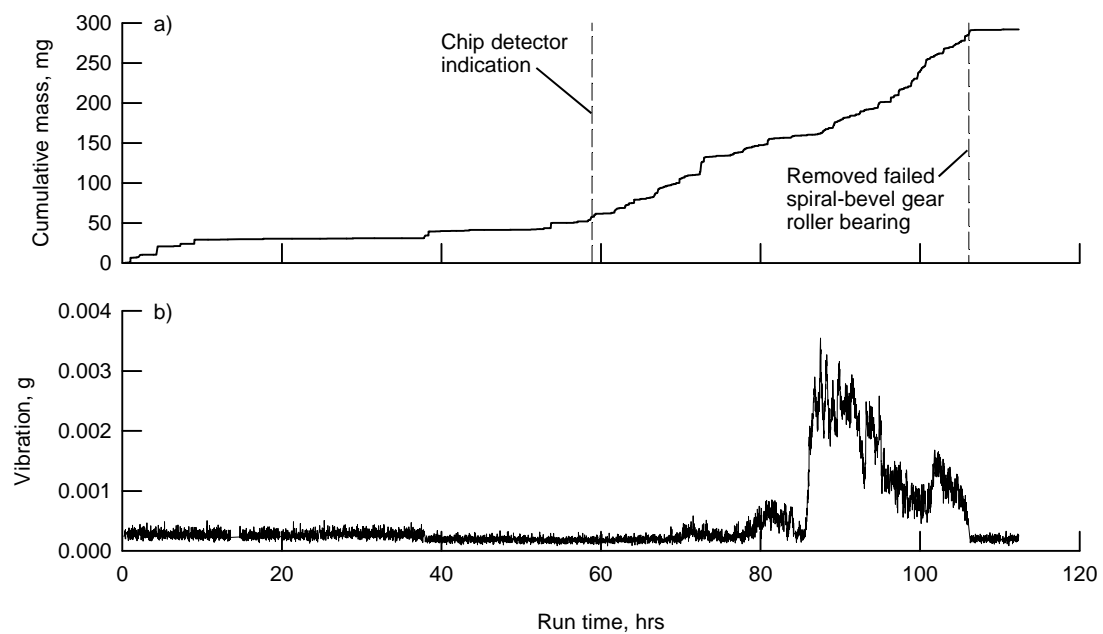
Bearing failure detection. As previously mentioned, a fatigue spall failure was discovered on the spiral-bevel gear roller bearing inner race at 106.11 hours run time. Fig. 25a shows the cumulative mass of the oil debris sensor as a function of run time for the entire test. From 0 to 9 hours, the debris increased from 0 to 29 mg, exhibiting a common "cleaning" condition. From the 29 to 58 hours, discrete increases in debris were measured. At 58 hours, the measured debris rapidly increased with time, giving a pronounced indication of component failure. At 59 hours, the OH-58 transmission flight hardware chip detector started to give indication of debris also. The transmission was disassembled and inspected at 106.11 hours run time, and the spalled spiral-bevel gear roller bearing inner race was discovered.

Fig. 25b shows the processed vibration data from MDSS accelerometer A3. This data used a common method for rolling element bearing fault detection in which the raw data was band pass filtered and

enveloped [12]. Shown in the figure are the magnitudes of the inner race bearing frequency of filtered and enveloped data. Some disturbance is shown at about 70 hours, but significant response to the fault is shown at about 86 hours. This analysis used band pass frequencies from 30 to 50 kHz. Fault detection was possibly in this range since high-frequency energy from the bearing was measured using the MDSS high-frequency accelerometers while low-frequency noise from the gear mesh was filtered and removed. Subsequent analysis was performed using lower band pass frequencies. Bearing failure was not detected, however, for lower limit band pass frequencies less than 30 kHz.

Fig. 25. Bearing fault detection condition indicators from MDSS data. a) Oil debris monitor
(ODM) cumulative mass. b) Accelerometer A3 bearing inner race condition indicator.
